Access Compliance Report

Public Rights-of-Way

(Curb Ramps)

Intersection ID: 15246	Main Street: HEFLIN_ST	Cross Street: MCVAY_ST	Location: NE
ADA ID: B757421A3191	Ramp Type: Perp	Initial Pass/Fail: Fail	Overall Compliance: No
Severity Score: 12.5			
Codes/Mitigation Info/Possible Solution		Field Measurements/Component Compliance

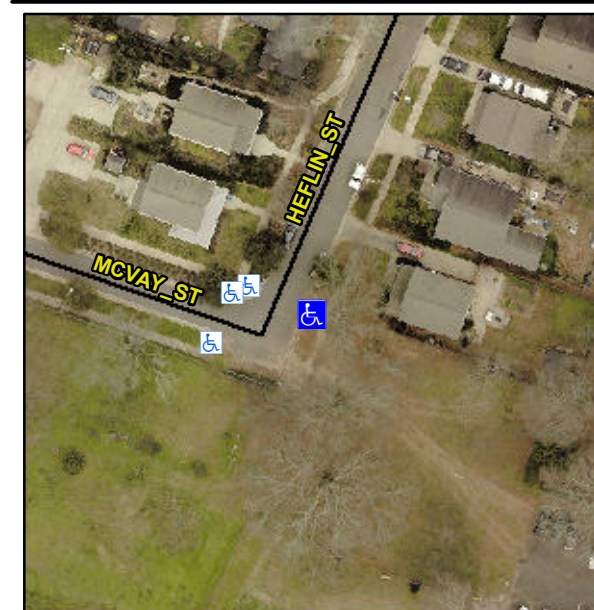
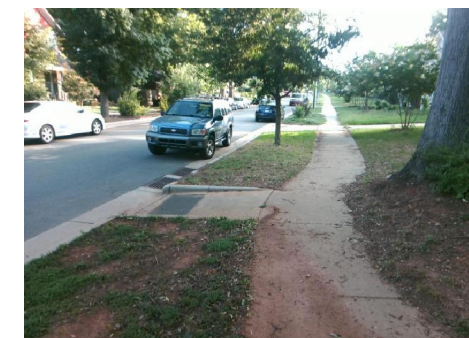
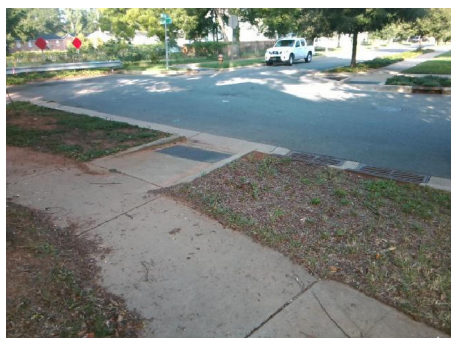
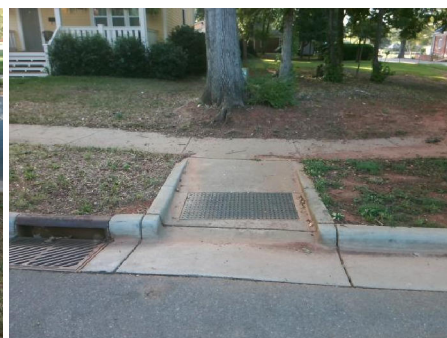
Not Found, R304.2.2

Compliance	Description	Data	Compliance	Description	Data
N/A	Ramp Length (in)	75.0	No	Ramp Slope (%)	8.5
Yes	Ramp Width (in)	59.0	Yes	Ramp XSlope (%)	1.3
N/A	Flare Type LT	N/A	N/A	Flare Type RT	N/A
N/A	Flare Slope LT (%)	N/A	N/A	Flare Slope RT (%)	N/A
N/A	Flare Traversable LT?	N/A	N/A	Flare Traversable RT?	N/A
N/A	Landing Length (in)	N/A	N/A	DWS Provided?	N/A
N/A	Landing Width (in)	N/A	N/A	DWS Contrast?	N/A
N/A	Landing Slope (%)	N/A	N/A	DWS Length (in)	N/A
N/A	Landing X Slope (%)	N/A	N/A	DWS Full Width?	N/A
N/A	Landing Curb? (Y/N)	N/A	N/A	DWS Offset (in)	N/A
N/A	Shared Landing?	N/A			
N/A	Gutter Ponding?	N/A	N/A	Gutter Slope (%)	N/A
N/A	Gutter Lip Ht (in)	N/A	N/A	Gutter X Slope (%)	N/A
N/A	Painted X Walk1?	No	N/A	Painted X Walk2?	N/A
	X Walk 1 Direction	To NW		X Walk 2 Direction	N/A
N/A	X Walk 1 Width (in)	N/A	N/A	X Walk 2 Width (in)	N/A
	X Walk 1 Slope (%)	2.9		X Walk 2 Slope (%)	N/A
	X Walk 1 X Slope (%)	0.5		X Walk 2 X Slope (%)	N/A

N/A	Ramp inside XWalk1?	N/A	N/A	Ramp inside XWalk2?	N/A
	Road Slope (%)	N/A	N/A	Clear Space?	N/A
	Road X Slope (%)	N/A	N/A	Clear Space to XWalk (in)	N/A
N/A	Any Obstructions?	N/A	N/A	Storm Grate/Utility Hazard?	N/A
	Obstruction Type			Storm Grate/Utility Type	
		N/A			N/A
			Yes	Surface Condition? (G/P)	Good

Possible Solutions:

Remove & Replace Entire Ramp.

Total Cost: \$ 1850.00
