Access Compliance Report

Public Rights-of-Way

(Curb Ramps)

Intersection ID: 49416	Main Street: CARMEL_RD	Cross Street: TUFTON_BRAE_CT	Location:	N
ADA ID: B75C3CDB29AA	Ramp Type: PerpDiag	Initial Pass/Fail: Fail	Overall Compliance: No	Severity Score: 8.75
Codes/Mitigation Info/Possible Solution		Field Measurements/Component Compliance

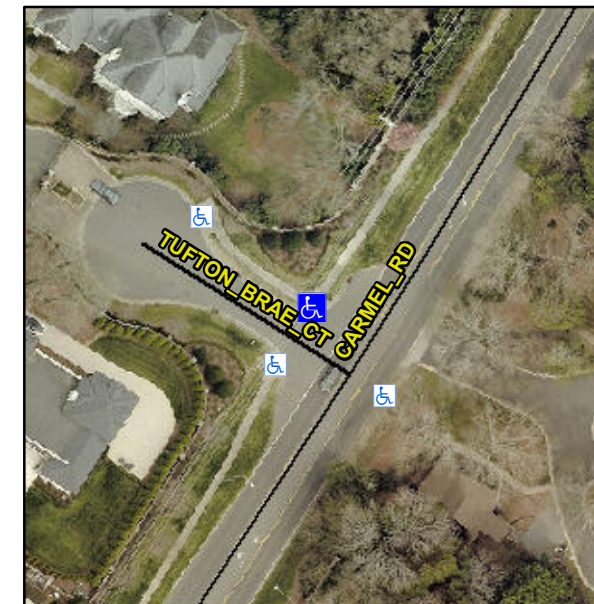
Not Found, R304.5.1

Compliance	Description	Data	Compliance	Description	Data
N/A	Ramp Length (in)	48.0	Yes	Ramp Slope (%)	7.3
No	Ramp Width (in)	47.0	Yes	Ramp XSlope (%)	1.0
N/A	Flare Type LT	N/A	N/A	Flare Type RT	N/A
N/A	Flare Slope LT (%)	N/A	N/A	Flare Slope RT (%)	N/A
N/A	Flare Traversable LT?	N/A	N/A	Flare Traversable RT?	N/A
N/A	Landing Length (in)	N/A	N/A	DWS Provided?	N/A
N/A	Landing Width (in)	N/A	N/A	DWS Contrast?	N/A
N/A	Landing Slope (%)	N/A	N/A	DWS Length (in)	N/A
N/A	Landing X Slope (%)	N/A	N/A	DWS Full Width?	N/A
N/A	Landing Curb? (Y/N)	N/A	N/A	DWS Offset (in)	N/A
N/A	Shared Landing?	N/A			
N/A	Gutter Ponding?	N/A	N/A	Gutter Slope (%)	N/A
N/A	Gutter Lip Ht (in)	N/A	N/A	Gutter X Slope (%)	N/A
N/A	Painted X Walk1?	No	N/A	Painted X Walk2?	No
	X Walk 1 Direction	To SW		X Walk 2 Direction	To SE
N/A	X Walk 1 Width (in)	N/A	N/A	X Walk 2 Width (in)	N/A
	X Walk 1 Slope (%)	1.9		X Walk 2 Slope (%)	2.3
	X Walk 1 X Slope (%)	3.5		X Walk 2 X Slope (%)	1.9

N/A	Ramp inside XWalk1?	N/A	N/A	Ramp inside XWalk2?	N/A
	Road Slope (%)	0.1	N/A	Clear Space?	N/A
	Road X Slope (%)	4.0	N/A	Clear Space to XWalk (in)	N/A
N/A	Any Obstructions?	N/A	N/A	Storm Grate/Utility Hazard?	N/A
	Obstruction Type			Storm Grate/Utility Type	
		N/A			N/A
			Yes	Surface Condition? (G/P)	Good

Remove & Replace Curb Ramp With Two New Directional Ramps or Equivalent.
