# Access Compliance Report

## Public Rights-of-Way

### (Curb Ramps)

| Intersection ID: 12342 | Main Street: E_8TH_ST | Cross Street: N_CALDWELL_ST | Location: W |

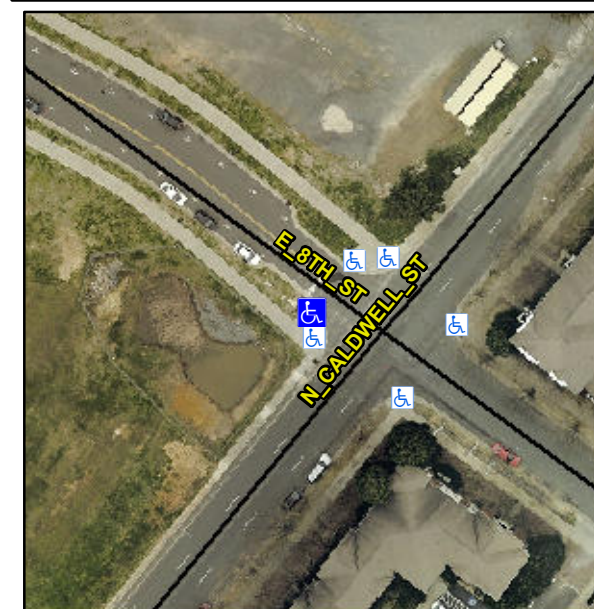
**Not Found, R304.5.1, R304.2.2**

| Compliance | Description | Data | Compliance | Description | Data |
|---|---|---|---|---|---|
| N/A | Ramp Length (in) | 72.0 | No | Ramp Slope (%) | 9.3 |
| No | Ramp Width (in) | 47.5 | Yes | Ramp XSlope (%) | 0.4 |

**Remove & Replace Entire Ramp.**
