# Access Compliance Report

## Public Rights-of-Way

### (Curb Ramps)

Intersection ID: 23537	Main Street: KIRCHENBAUM_DR	Cross Street: OBERBECK_LN	Location:	W
ADA ID: B767D8DEFD35	Ramp Type: PerpDiag	Initial Pass/Fail: Fail	Overall Compliance: No	Severity Score: 10
Codes/Mitigation Info/Possible Solution		Field Measurements/Component Compliance

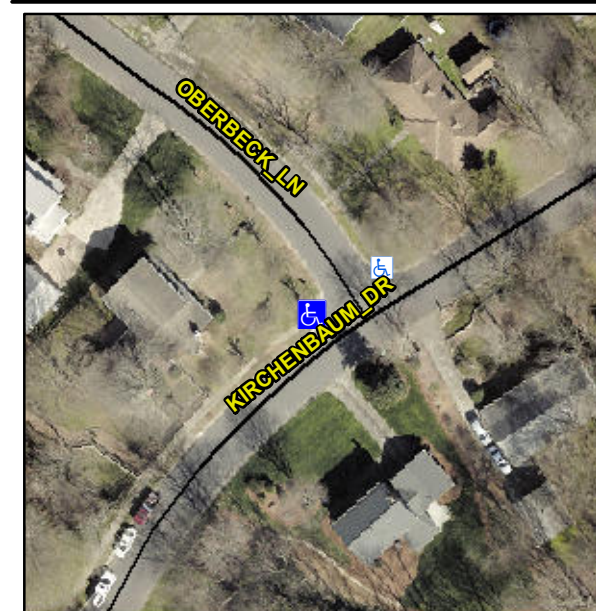
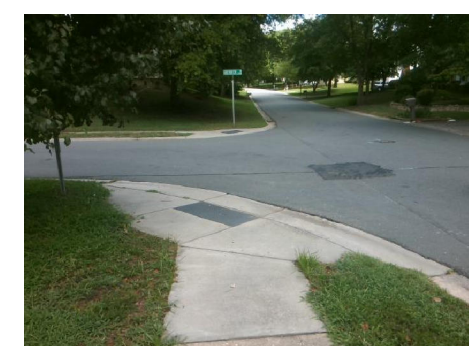
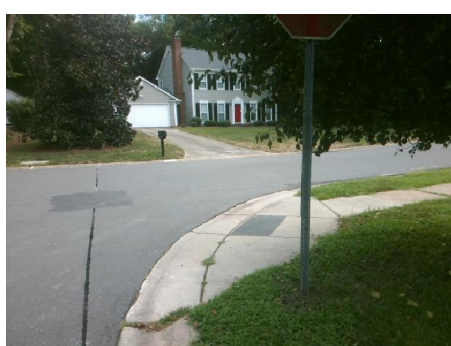
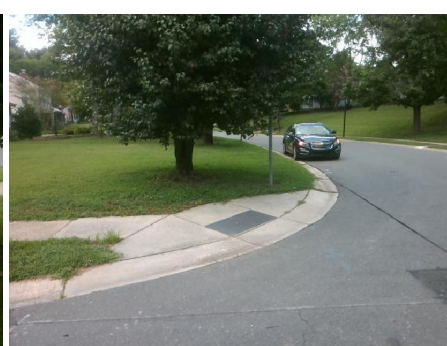
**Not Found, R304.5.1, R304.5.3**

Compliance	Description	Data	Compliance	Description	Data
N/A	Ramp Length (in)	61.0	Yes	Ramp Slope (%)	6.5
No	Ramp Width (in)	45.0	No	Ramp XSlope (%)	2.5
N/A	Flare Type LT	N/A	N/A	Flare Type RT	N/A
N/A	Flare Slope LT (%)	N/A	N/A	Flare Slope RT (%)	N/A
N/A	Flare Traversable LT?	N/A	N/A	Flare Traversable RT?	N/A
N/A	Landing Length (in)	N/A	N/A	DWS Provided?	N/A
N/A	Landing Width (in)	N/A	N/A	DWS Contrast?	N/A
N/A	Landing Slope (%)	N/A	N/A	DWS Length (in)	N/A
N/A	Landing X Slope (%)	N/A	N/A	DWS Full Width?	N/A
N/A	Landing Curb? (Y/N)	N/A	N/A	DWS Offset (in)	N/A
N/A	Shared Landing?	N/A			
N/A	Gutter Ponding?	N/A	N/A	Gutter Slope (%)	N/A
N/A	Gutter Lip Ht (in)	N/A	N/A	Gutter X Slope (%)	N/A
N/A	Painted X Walk1?	No	N/A	Painted X Walk2?	No
	X Walk 1 Direction	To S		X Walk 2 Direction	To E
N/A	X Walk 1 Width (in)	N/A	N/A	X Walk 2 Width (in)	N/A
	X Walk 1 Slope (%)	2.8		X Walk 2 Slope (%)	5.2
	X Walk 1 X Slope (%)	2.1		X Walk 2 X Slope (%)	0.9

N/A	Ramp inside XWalk1?	N/A	N/A	Ramp inside XWalk2?	N/A
	Road Slope (%)	0.9	N/A	Clear Space?	N/A
	Road X Slope (%)	4.8	N/A	Clear Space to XWalk (in)	N/A
N/A	Any Obstructions?	N/A	N/A	Storm Grate/Utility Hazard?	N/A
	Obstruction Type			Storm Grate/Utility Type	
		N/A			N/A
			Yes	Surface Condition? (G/P)	Good

**Remove & Replace Curb Ramp With Two New Directional Ramps or Equivalent.**
