Access Compliance Report

Public Rights-of-Way

(Curb Ramps)

Intersection ID: 7726	Main Street: HIDDEN_VALLEY_RD	Cross Street: MEBANE_DR	Location:	NW
ADA ID: B76A708C9AF4	Ramp Type: Perp	Initial Pass/Fail: Fail	Overall Compliance: No	Severity Score: 10

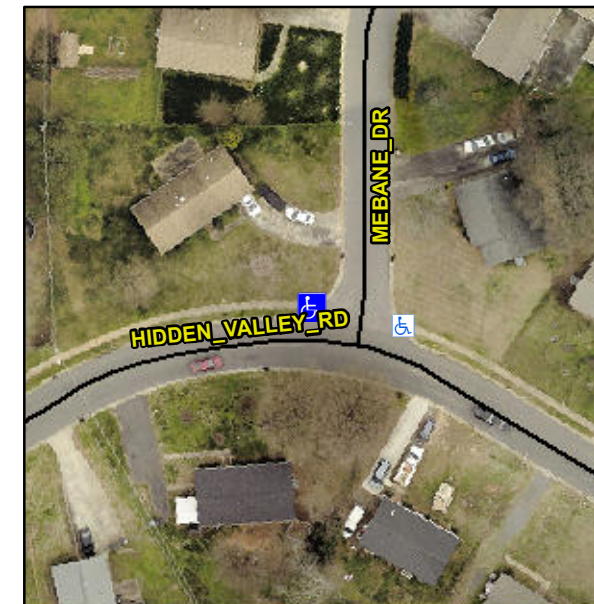
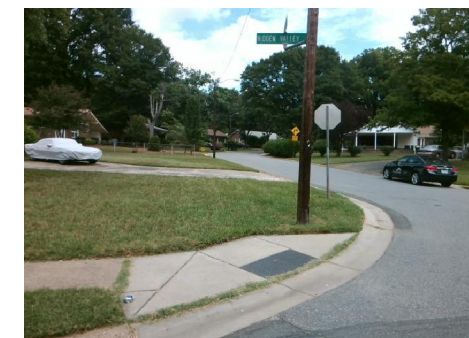
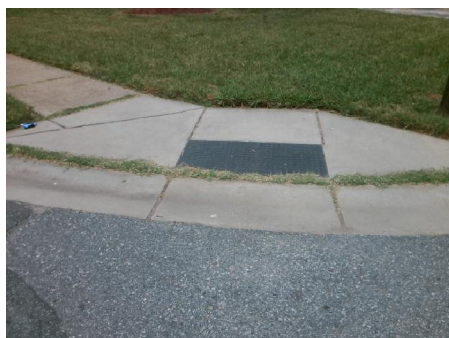
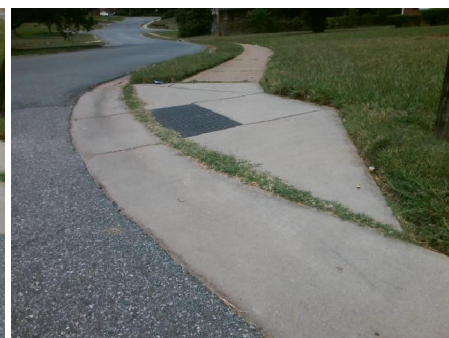
Not Found, R304.5.1, R304.5.3

Compliance	Description	Data	Compliance	Description	Data
N/A	Ramp Length (in)	61.5	Yes	Ramp Slope (%)	7.4
No	Ramp Width (in)	47.5	No	Ramp XSlope (%)	3.3
N/A	Flare Type LT	N/A	N/A	Flare Type RT	N/A
N/A	Flare Slope LT (%)	N/A	N/A	Flare Slope RT (%)	N/A
N/A	Flare Traversable LT?	N/A	N/A	Flare Traversable RT?	N/A
N/A	Landing Length (in)	N/A	N/A	DWS Provided?	N/A
N/A	Landing Width (in)	N/A	N/A	DWS Contrast?	N/A
N/A	Landing Slope (%)	N/A	N/A	DWS Length (in)	N/A
N/A	Landing X Slope (%)	N/A	N/A	DWS Full Width?	N/A
N/A	Landing Curb? (Y/N)	N/A	N/A	DWS Offset (in)	N/A
N/A	Shared Landing?	N/A			
N/A	Gutter Ponding?	N/A	N/A	Gutter Slope (%)	N/A
N/A	Gutter Lip Ht (in)	N/A	N/A	Gutter X Slope (%)	N/A
N/A	Painted X Walk1?	No	N/A	Painted X Walk2?	N/A
	X Walk 1 Direction	To E		X Walk 2 Direction	N/A
N/A	X Walk 1 Width (in)	N/A	N/A	X Walk 2 Width (in)	N/A
	X Walk 1 Slope (%)	2.4		X Walk 2 Slope (%)	N/A
	X Walk 1 X Slope (%)	0.4		X Walk 2 X Slope (%)	N/A

N/A	Ramp inside XWalk1?	N/A	N/A	Ramp inside XWalk2?	N/A
	Road Slope (%)	N/A	N/A	Clear Space?	N/A
	Road X Slope (%)	N/A	N/A	Clear Space to XWalk (in)	N/A
N/A	Any Obstructions?	N/A	N/A	Storm Grate/Utility Hazard?	N/A
	Obstruction Type			Storm Grate/Utility Type	
		N/A			N/A
			Yes	Surface Condition? (G/P)	Good

Remove & Replace Entire Ramp.

Total Cost: \$ 1850.00
