Access Compliance Report

Public Rights-of-Way

(Curb Ramps)

Intersection ID: 50616	Main Street: PADDLE_OAK_RD	Cross Street: FAWN_LILY	Location: NW
ADA ID: B76ECCFF9BF	Ramp Type: Perp	Initial Pass/Fail: Fail	Overall Compliance: No
Severity Score: 21.25			
Codes/Mitigation Info/Possible Solution		Field Measurements/Component Compliance

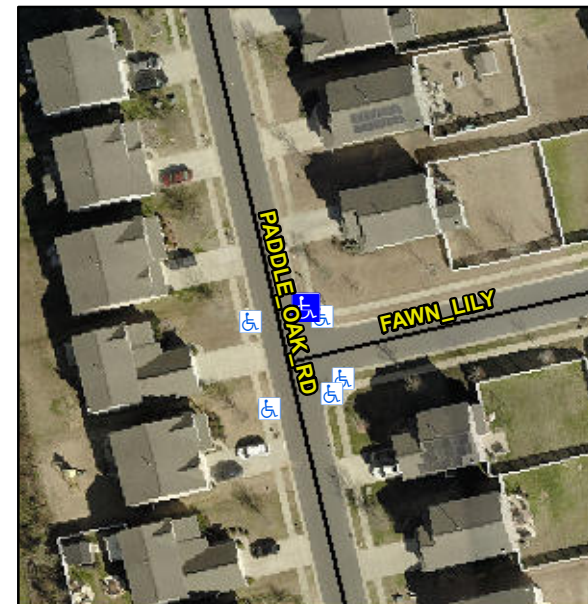
Compliance	Description	Data	Compliance	Description	Data
N/A	Ramp Length (in)	49.5	No	Ramp Slope (%)	9.4
No	Ramp Width (in)	47.5	Yes	Ramp XSlope (%)	1.9
N/A	Flare Type LT	N/A	N/A	Flare Type RT	N/A
N/A	Flare Slope LT (%)	N/A	N/A	Flare Slope RT (%)	N/A
N/A	Flare Traversable LT?	N/A	N/A	Flare Traversable RT?	N/A
N/A	Landing Length (in)	N/A	N/A	DWS Provided?	N/A
N/A	Landing Width (in)	N/A	N/A	DWS Contrast?	N/A
N/A	Landing Slope (%)	N/A	N/A	DWS Length (in)	N/A
N/A	Landing X Slope (%)	N/A	N/A	DWS Full Width?	N/A
N/A	Landing Curb? (Y/N)	N/A	N/A	DWS Offset (in)	N/A
N/A	Shared Landing?	N/A			
N/A	Gutter Ponding?	N/A	N/A	Gutter Slope (%)	N/A
N/A	Gutter Lip Ht (in)	N/A	N/A	Gutter X Slope (%)	N/A
N/A	Painted X Walk1?	No	N/A	Painted X Walk2?	N/A
	X Walk 1 Direction	To W		X Walk 2 Direction	N/A
N/A	X Walk 1 Width (in)	N/A	N/A	X Walk 2 Width (in)	N/A
	X Walk 1 Slope (%)	1.6		X Walk 2 Slope (%)	N/A
	X Walk 1 X Slope (%)	3.0		X Walk 2 X Slope (%)	N/A

N/A	Ramp inside XWalk1?	N/A	N/A	Ramp inside XWalk2?	N/A
	Road Slope (%)	N/A	N/A	Clear Space?	N/A
	Road X Slope (%)	N/A	N/A	Clear Space to XWalk (in)	N/A
N/A	Any Obstructions?	N/A	N/A	Storm Grate/Utility Hazard?	N/A
	Obstruction Type			Storm Grate/Utility Type	
		N/A			N/A
			Yes	Surface Condition? (G/P)	Good

Possible Solutions:

Remove & Replace Entire Ramp.
