# Access Compliance Report

## Public Rights-of-Way

### (Curb Ramps)

| Intersection ID: 28015 | Main Street: LANCASTER_HY | Cross Street: PROVIDENCE_RD_WEST | Location: SW |

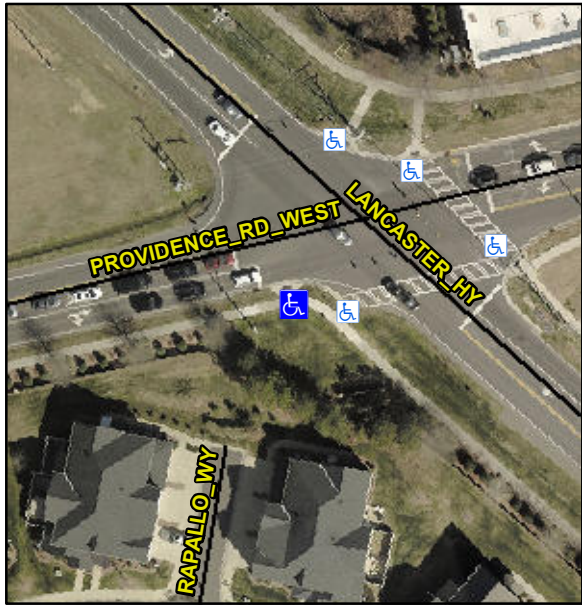
| ADA ID: B777C12A787A | Ramp Type: Perp | Initial Pass/Fail: Fail | Overall Compliance: No<br>Severity Score: 13.75 |

| Codes/Mitigation Info/Possible Solution | | | Field Measurements/Component Compliance | | | | | | | |
|---|---|---|---|---|---|---|---|---|---|---|
| | Remove & Replace Entire Ramp. | | N/A | | Ramp Length (in) | 71.0 | No | | Ramp Slope (%) | 9.3 |
| | | | Yes | | Ramp Width (in) | 59.0 | No | | Ramp XSlope (%) | 2.7 |
| PROW/ADA: | | Not Found, R304.2.2, R304.5.3 | | | N/A | | | N/A | | N/A |
