Access Compliance Report

Public Rights-of-Way

(Curb Ramps)

Intersection ID: 50634	Main Street: CORLA ROSE RD	Cross Street: BLUE JASPER RD	Location: NE
ADA ID: B77B2639AFF9	Ramp Type: Perp	Initial Pass/Fail: Fail	Overall Compliance: No
Severity Score: 10			
Codes/Mitigation Info/Possible Solution		Field Measurements/Component Compliance

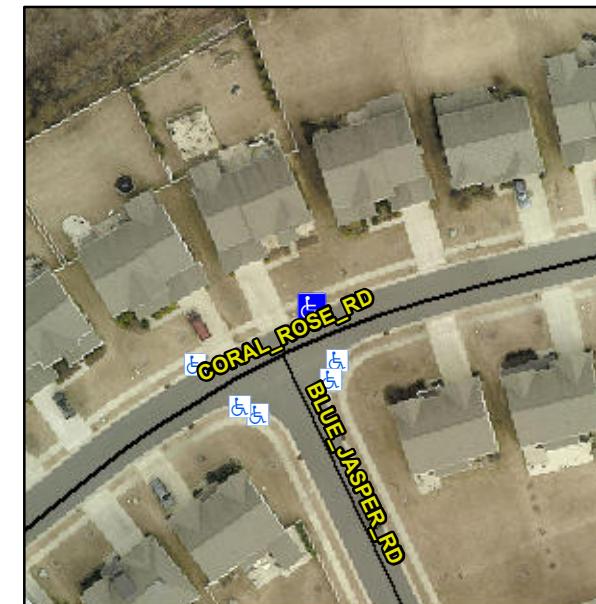
Not Found, R304.5.1, R304.5.3

Compliance	Description	Data	Compliance	Description	Data
N/A	Ramp Length (in)	47.5	Yes	Ramp Slope (%)	5.2
No	Ramp Width (in)	46.5	No	Ramp XSlope (%)	2.6
N/A	Flare Type LT	N/A	N/A	Flare Type RT	N/A
N/A	Flare Slope LT (%)	N/A	N/A	Flare Slope RT (%)	N/A
N/A	Flare Traversable LT?	N/A	N/A	Flare Traversable RT?	N/A
N/A	Landing Length (in)	N/A	N/A	DWS Provided?	N/A
N/A	Landing Width (in)	N/A	N/A	DWS Contrast?	N/A
N/A	Landing Slope (%)	N/A	N/A	DWS Length (in)	N/A
N/A	Landing X Slope (%)	N/A	N/A	DWS Full Width?	N/A
N/A	Landing Curb? (Y/N)	N/A	N/A	DWS Offset (in)	N/A
N/A	Shared Landing?	N/A			
N/A	Gutter Ponding?	N/A	N/A	Gutter Slope (%)	N/A
N/A	Gutter Lip Ht (in)	N/A	N/A	Gutter X Slope (%)	N/A
N/A	Painted X Walk1?	No	N/A	Painted X Walk2?	N/A
	X Walk 1 Direction	To SE		X Walk 2 Direction	N/A
N/A	X Walk 1 Width (in)	N/A	N/A	X Walk 2 Width (in)	N/A
	X Walk 1 Slope (%)	4.3		X Walk 2 Slope (%)	N/A
	X Walk 1 X Slope (%)	1.3		X Walk 2 X Slope (%)	N/A

N/A	Ramp inside XWalk1?	N/A	N/A	Ramp inside XWalk2?	N/A
	Road Slope (%)	N/A	N/A	Clear Space?	N/A
	Road X Slope (%)	N/A	N/A	Clear Space to XWalk (in)	N/A
N/A	Any Obstructions?	N/A	N/A	Storm Grate/Utility Hazard?	N/A
	Obstruction Type			Storm Grate/Utility Type	
		N/A			N/A
			Yes	Surface Condition? (G/P)	Good

Remove & Replace Entire Ramp.
