# Access Compliance Report

## Public Rights-of-Way

### (Curb Ramps)

Intersection ID: 8157	Main Street: N_TRYON_ST	Cross Street: ORR_RD	Location: NW
ADA ID: B77BFA962B7B	Ramp Type: Perp	Initial Pass/Fail: Fail	Overall Compliance: No
		Severity Score: 12.5

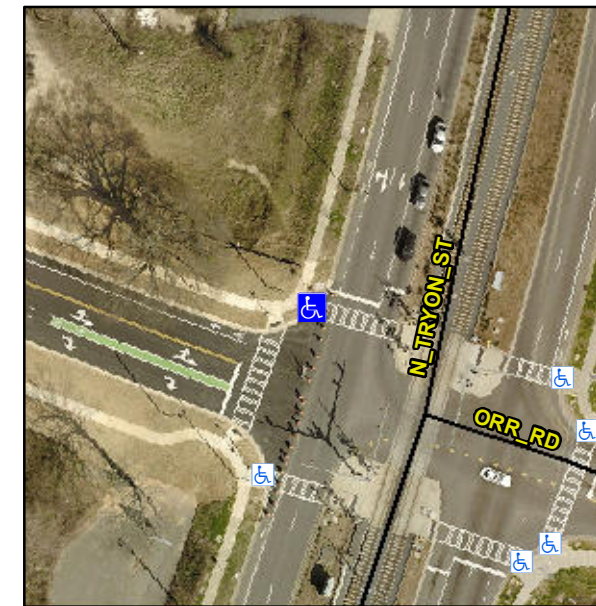
**R304.2.2**

Compliance	Description	Data	Compliance	Description	Data
N/A	Ramp Length (in)	97.0	No	Ramp Slope (%)	9.3
Yes	Ramp Width (in)	91.0	Yes	Ramp XSlope (%)	0.2
N/A	Flare Type LT	N/A	N/A	Flare Type RT	N/A
N/A	Flare Slope LT (%)	N/A	N/A	Flare Slope RT (%)	N/A
N/A	Flare Traversable LT?	N/A	N/A	Flare Traversable RT?	N/A
N/A	Landing Length (in)	N/A	N/A	DWS Provided?	N/A
N/A	Landing Width (in)	N/A	N/A	DWS Contrast?	N/A
N/A	Landing Slope (%)	N/A	N/A	DWS Length (in)	N/A
N/A	Landing X Slope (%)	N/A	N/A	DWS Full Width?	N/A
N/A	Landing Curb? (Y/N)	N/A	N/A	DWS Offset (in)	N/A
N/A	Shared Landing?	N/A			
N/A	Gutter Ponding?	N/A	N/A	Gutter Slope (%)	N/A
N/A	Gutter Lip Ht (in)	N/A	N/A	Gutter X Slope (%)	N/A
N/A	Painted X Walk1?	Yes	N/A	Painted X Walk2?	N/A
	X Walk 1 Direction	To E		X Walk 2 Direction	N/A
N/A	X Walk 1 Width (in)	97.0	N/A	X Walk 2 Width (in)	N/A
	X Walk 1 Slope (%)	2.6		X Walk 2 Slope (%)	N/A
	X Walk 1 X Slope (%)	0.8		X Walk 2 X Slope (%)	N/A

N/A	Ramp inside XWalk1?	Yes	N/A	Ramp inside XWalk2?	N/A
	Road Slope (%)	N/A	N/A	Clear Space?	N/A
	Road X Slope (%)	N/A	N/A	Clear Space to XWalk (in)	N/A
N/A	Any Obstructions?	N/A	N/A	Storm Grate/Utility Hazard?	N/A
	Obstruction Type			Storm Grate/Utility Type	
		N/A			N/A
		Yes		Surface Condition? (G/P)	Good

**Remove & Replace Entire Ramp.**

**\$ 1850.00**
