Access Compliance Report

Public Rights-of-Way

(Curb Ramps)

Intersection ID: 50611	Main Street: COTTON_GUM_RD	Cross Street: DOWNY_BIRCH_RD	Location: NW
ADA ID: B77D8B82AE4E	Ramp Type: Perp	Initial Pass/Fail: Pass	Overall Compliance: No
Severity Score: 5			
Codes/Mitigation Info/Possible Solution		Field Measurements/Component Compliance

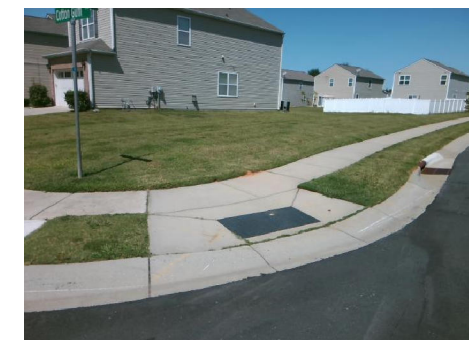
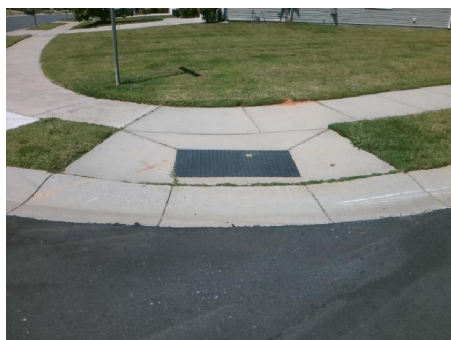
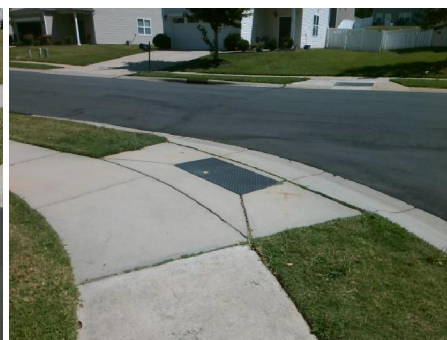
Compliance	Description	Data	Compliance	Description	Data
N/A	Ramp Length (in)	47.5	Yes	Ramp Slope (%)	7.1
Yes	Ramp Width (in)	48.0	Yes	Ramp XSlope (%)	0.3
N/A	Flare Type LT	Sloped	N/A	Flare Type RT	N/A
N/A	Flare Slope LT (%)	2.0	N/A	Flare Slope RT (%)	4.1
N/A	Flare Traversable LT?	No	N/A	Flare Traversable RT?	No
Yes	Landing Length (in)	48.0	Yes	DWS Provided?	Yes
Yes	Landing Width (in)	101.0	Yes	DWS Contrast?	Yes
Yes	Landing Slope (%)	0.3	Yes	DWS Length (in)	24.5
No	Landing X Slope (%)	3.0	Yes	DWS Full Width?	Yes
N/A	Landing Curb? (Y/N)	No	No	DWS Offset (in)	5.5
N/A	Shared Landing?	Yes			
Yes	Gutter Ponding?	No	No	Gutter Slope (%)	10.0
Yes	Gutter Lip Ht (in)	0.0	Yes	Gutter X Slope (%)	1.3
N/A	Painted X Walk1?	No	N/A	Painted X Walk2?	N/A
	X Walk 1 Direction	To E		X Walk 2 Direction	N/A
N/A	X Walk 1 Width (in)	N/A	N/A	X Walk 2 Width (in)	N/A
	X Walk 1 Slope (%)	3.4		X Walk 2 Slope (%)	N/A
	X Walk 1 X Slope (%)	2.0		X Walk 2 X Slope (%)	N/A

N/A	Ramp inside XWalk1?	N/A	N/A	Ramp inside XWalk2?	N/A
	Road Slope (%)	N/A	N/A	Clear Space?	Yes
	Road X Slope (%)	N/A	N/A	Clear Space to XWalk (in)	N/A
Yes	Any Obstructions?	No	Yes	Storm Grate/Utility Hazard?	No
	Obstruction Type			Storm Grate/Utility Type	
		N/A			N/A
			Yes	Surface Condition? (G/P)	Good

**Remove & Replace Entire Ramp.
Remove & Replace Gutter.**
