Access Compliance Report

Public Rights-of-Way

(Curb Ramps)

Intersection ID: 14455	Main Street: EAST_BV	Cross Street: WINTHROP_AV	Location: NE
ADA ID: B789662809B3	Ramp Type: Directional1	Initial Pass/Fail: Fail	Overall Compliance: No
Severity Score: 12.5			
Codes/Mitigation Info/Possible Solution		Field Measurements/Component Compliance

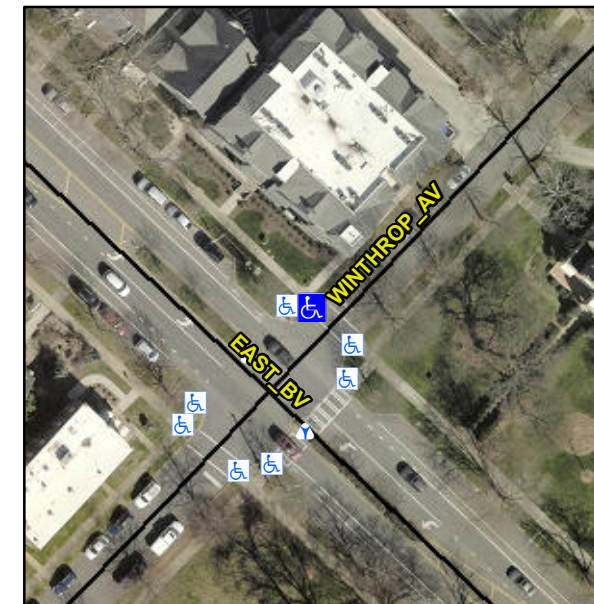
Compliance	Description	Data	Compliance	Description	Data
N/A	Ramp Length (in)	72.0	N/A	Grade Break?	N/A
Yes	Ramp Width (in)	71.0	N/A	Grade Break Slope (%)	0.0
No	Ramp Slope (%)	10.4	N/A	Grade Break XSlope (%)	0.0
Yes	Ramp XSlope (%)	0.8			
N/A	Flare Type LT	N/A	N/A	Flare Type RT	N/A
N/A	Flare Slope LT (%)	N/A	N/A	Flare Slope RT (%)	0.0
N/A	Flare Traversable LT?	N/A	N/A	Flare Traversable RT?	N/A
N/A	Landing Length (in)	0.0	N/A	DWS Provided?	N/A
N/A	Landing Width (in)	0.0	N/A	DWS Contrast?	N/A
N/A	Landing Slope (%)	0.0	N/A	DWS Length (in)	N/A
N/A	Landing X Slope (%)	0.0	N/A	DWS Full Width?	N/A
N/A	Landing Curb? (Y/N)	N/A	N/A	DWS Offset LT (in)	N/A
N/A	Shared Landing?	N/A	N/A	DWS Offset RT (in)	N/A
N/A	Gutter Ponding?	0.0	N/A	Gutter Slope (%)	N/A
N/A	Gutter Lip Ht (in)	0.0	N/A	Gutter X Slope (%)	N/A
N/A	Painted X Walk1?	Yes		Road Slope (%)	2.4
	X Walk 1 Direction	To SE		Road X Slope (%)	2.6
	X Walk 1 Width (in)	110.0		Clear Space?	N/A

X Walk 1 Slope (%)	2.4	N/A	Clear Space to XWalk (in)	N/A
	X Walk 1 X Slope (%)	2.6	N/A	Storm Grate/Utility Hazard?	N/A
N/A	Ramp inside XWalk1?	Yes		Storm Grate/Utility Type	
N/A	Any Obstructions?	N/A			N/A
	Obstruction Type		Yes	Surface Condition? (G/P)	Good
			N/A	Curb Slope (%)	13.0

Possible Solutions:

Remove & Replace Entire Ramp.

R304.2.2
