# Access Compliance Report

## Public Rights-of-Way

### (Curb Ramps)

Intersection ID: N/A	Main Street: LITTLE ROCK RD	Cross Street: N/A	Location: W
ADA ID: B78B0A6D3F7F	Ramp Type: Directional1	Initial Pass/Fail: Pass	Overall Compliance: No
		Severity Score: 0.25

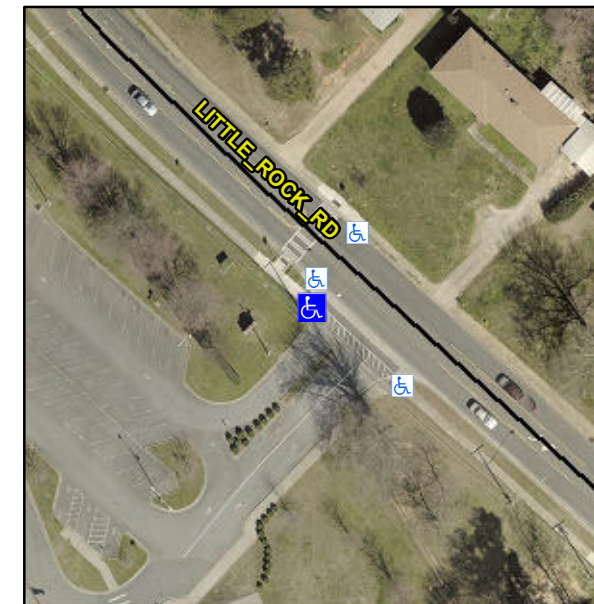
Compliance	Description	Data	Compliance	Description	Data
N/A	Ramp Length (in)	63.0	Yes	Grade Break?	Yes
Yes	Ramp Width (in)	59.0	Yes	Grade Break Slope (%)	0.9
Yes	Ramp Slope (%)	0.7	Yes	Grade Break XSlope (%)	2.0
No	Ramp XSlope (%)	2.3			
Yes	Flare Type LT	N/A	Yes	Flare Type RT	N/A
N/A	Flare Slope LT (%)	N/A	N/A	Flare Slope RT (%)	N/A
N/A	Flare Traversable LT?	No	N/A	Flare Traversable RT?	No
Yes	Landing Length (in)	63.0	Yes	DWS Provided?	Yes
Yes	Landing Width (in)	59.0	Yes	DWS Contrast?	Yes
Yes	Landing Slope (%)	1.9	Yes	DWS Length (in)	24.0
Yes	Landing X Slope (%)	1.1	Yes	DWS Full Width?	Yes
N/A	Landing Curb? (Y/N)	N/A	Yes	DWS Offset LT (in)	43.0
N/A	Shared Landing?	No	Yes	DWS Offset RT (in)	2.0
Yes	Gutter Ponding?	No	Yes	Gutter Slope (%)	0.8
Yes	Gutter Lip Ht (in)	0.0	Yes	Gutter X Slope (%)	1.2
N/A	Painted X Walk1?	Yes		Road Slope (%)	0.5
	X Walk 1 Direction	To SE		Road X Slope (%)	1.4
	X Walk 1 Width (in)	60.0		Clear Space?	Yes

X Walk 1 Slope (%)	0.5	N/A	Clear Space to XWalk (in)	N/A
	X Walk 1 X Slope (%)	1.4	Yes	Storm Grate/Utility Hazard?	No
Yes	Ramp inside XWalk1?	Yes		Storm Grate/Utility Type	
Yes	Any Obstructions?	No			N/A
	Obstruction Type		Yes	Surface Condition? (G/P)	Good
			N/A	Curb Slope (%)	3.2

Possible Solutions:

**Remove & Replace Entire Ramp.**

**R304.5.3**
