Access Compliance Report

Public Rights-of-Way

(Curb Ramps)

Intersection ID: 23715	Main Street: BRANDON_FOREST_DR	Cross Street: VON_THURINGER_CT	Location: SE
ADA ID: B7930729CDD1	Ramp Type: PerpDiag	Initial Pass/Fail: Fail	Overall Compliance: No
Severity Score: 8.75			
Codes/Mitigation Info/Possible Solution		Field Measurements/Component Compliance

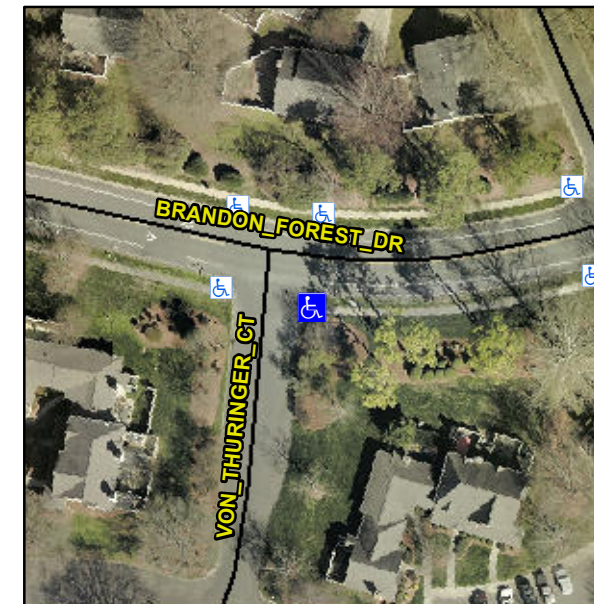
Not Found, R304.5.1

Compliance	Description	Data	Compliance	Description	Data
N/A	Ramp Length (in)	41.0	Yes	Ramp Slope (%)	5.3
No	Ramp Width (in)	46.0	Yes	Ramp XSlope (%)	1.6
N/A	Flare Type LT	N/A	N/A	Flare Type RT	N/A
N/A	Flare Slope LT (%)	N/A	N/A	Flare Slope RT (%)	N/A
N/A	Flare Traversable LT?	N/A	N/A	Flare Traversable RT?	N/A
N/A	Landing Length (in)	N/A	N/A	DWS Provided?	N/A
N/A	Landing Width (in)	N/A	N/A	DWS Contrast?	N/A
N/A	Landing Slope (%)	N/A	N/A	DWS Length (in)	N/A
N/A	Landing X Slope (%)	N/A	N/A	DWS Full Width?	N/A
N/A	Landing Curb? (Y/N)	N/A	N/A	DWS Offset (in)	N/A
N/A	Shared Landing?	N/A			
N/A	Gutter Ponding?	N/A	N/A	Gutter Slope (%)	N/A
N/A	Gutter Lip Ht (in)	N/A	N/A	Gutter X Slope (%)	N/A
N/A	Painted X Walk1?	No	N/A	Painted X Walk2?	No
	X Walk 1 Direction	To N		X Walk 2 Direction	To NW
N/A	X Walk 1 Width (in)	N/A	N/A	X Walk 2 Width (in)	N/A
	X Walk 1 Slope (%)	4.3		X Walk 2 Slope (%)	0.3
	X Walk 1 X Slope (%)	0.8		X Walk 2 X Slope (%)	0.3

N/A	Ramp inside XWalk1?	N/A	N/A	Ramp inside XWalk2?	N/A
	Road Slope (%)	0.9	N/A	Clear Space?	N/A
	Road X Slope (%)	1.3	N/A	Clear Space to XWalk (in)	N/A
N/A	Any Obstructions?	N/A	N/A	Storm Grate/Utility Hazard?	N/A
	Obstruction Type			Storm Grate/Utility Type	
		N/A			N/A
			Yes	Surface Condition? (G/P)	Good

Remove & Replace Curb Ramp With Two New Directional Ramps or Equivalent.
