Access Compliance Report Public Rights-of-Way (Curb Ramps)

Intersection ID: 15254 Main Street: IDEAL_WY Cross Street: PARK_RD Location: NE

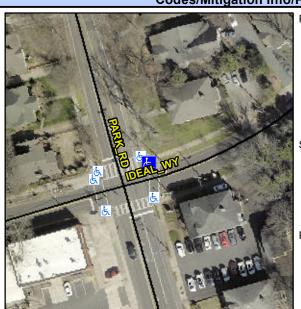
Overall Compliance: No ADA ID: B7A3D39AE92E Ramp Type: Perp Initial Pass/Fail: Fail Severity Score: 18.75

Field Measurements/Component Compliance								
Comp	liance Description	Data	Comp	liance l	Description	Data		
N/A	Ramp Length (in)	128.0	Yes	Ramp	Slope (%)	7.7		
No	Ramp Width (in)	35.0	No	Ramp 2	XSlope (%)	2.3		
N/A	Flare Type LT	N/A	N/A	Flare T	ype RT	N/A		
N/A	Flare Slope LT (%)	N/A	N/A	Flare S	Slope RT (%)	N/A		
N/A	Flare Traversable LT?	N/A	N/A	Flare T	raversable RT?	N/A		
N/A	Landing Length (in)	N/A	N/A	DWS F	Provided?	N/A		
N/A	Landing Width (in)	N/A	N/A	DWS C	Contrast?	N/A		
N/A	Landing Slope (%)	N/A	N/A	DWS L	ength (in)	N/A		
N/A	Landing X Slope (%)	N/A	N/A	DWS F	Full Width?	N/A		
N/A	Landing Curb? (Y/N)	N/A	N/A	DWS C	Offset (in)	N/A		
N/A	Shared Landing?	N/A						
N/A	Gutter Ponding?	N/A	N/A	Gutter	Slope (%)	N/A		
N/A	Gutter Lip Ht (in)	N/A	N/A	Gutter	X Slope (%)	N/A		
N/A	Painted X Walk1?	Yes	N/A	Painted	d X Walk2?	N/A		
	X Walk 1 Direction	To S		X Walk	2 Direction	N/A		
N/A	X Walk 1 Width (in)	115.0	N/A	X Walk	2 Width (in)	N/A

X Walk 1 Slope (%)	5.2		X Walk	2 Slope (%)	N/A		
	X Walk 1 X Slope (%)	0.2		X Walk	2 X Slope (%)	N/A		
N/A	Ramp inside XWalk1?	No	N/A	Ramp	inside XWalk2?	N/A		
	Road Slope (%)	N/A	N/A	Clear S	Space?	N/A		
	Road X Slope (%)	N/A	N/A	Clear S	Space to XWalk (in)	N/A		
N/A	Any Obstructions?	N/A	N/A	Storm	Grate/Utility Hazard?	N/A		
	Obstruction Type			Storm	Grate/Utility Type			
		N/A				N/A		
			Yes	Surface	e Condition? (G/P)	Good

Possible Solution	
Possible Solutions:	<u>c</u>
Remove & Replace Entire Ramp.	N
Restripe Crosswalk.	N
	N
	N
	N
	N
Surveyor Notes:	N
N/A	N
	N
	N
	N
PROW/ADA:	N
R304.5.1, R304.5.3	N
	N
	N
