Access Compliance Report

Public Rights-of-Way

(Curb Ramps)

Intersection ID: 47227	Main Street: VALLEYDALE_RD	Cross Street: OAKSHIRE_CR	Location:	N
ADA ID: B7A6A31F7DE5	Ramp Type: PerpDiag	Initial Pass/Fail: Pass	Overall Compliance: No	Severity Score: 10

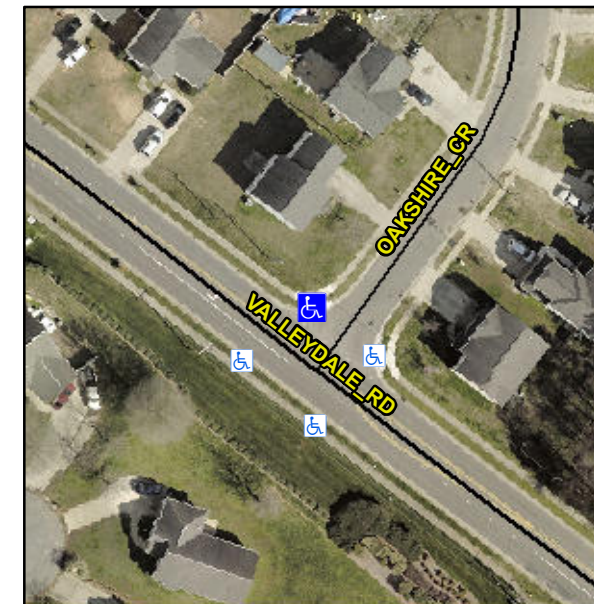
Not Found, R304.2.1, R304.5.3, R305

Compliance	Description	Data	Compliance	Description	Data
N/A	Ramp Length (in)	50.0	Yes	Ramp Slope (%)	7.5
Yes	Ramp Width (in)	52.5	Yes	Ramp XSlope (%)	0.7
N/A	Flare Type LT	Sloped	N/A	Flare Type RT	N/A
N/A	Flare Slope LT (%)	8.1	Yes	Flare Slope RT (%)	1.6
N/A	Flare Traversable LT?	Yes	N/A	Flare Traversable RT?	Yes
No	Landing Length (in)	44.0	No	DWS Provided?	No
Yes	Landing Width (in)	51.0	N/A	DWS Contrast?	No
Yes	Landing Slope (%)	0.9	N/A	DWS Length (in)	N/A
No	Landing X Slope (%)	2.6	N/A	DWS Full Width?	No
N/A	Landing Curb? (Y/N)	No	N/A	DWS Offset (in)	N/A
N/A	Shared Landing?	No			
Yes	Gutter Ponding?	No	Yes	Gutter Slope (%)	1.3
Yes	Gutter Lip Ht (in)	0.0	Yes	Gutter X Slope (%)	0.4
N/A	Painted X Walk1?	No	N/A	Painted X Walk2?	No
	X Walk 1 Direction	To SW		X Walk 2 Direction	To SE
N/A	X Walk 1 Width (in)	N/A	N/A	X Walk 2 Width (in)	N/A
	X Walk 1 Slope (%)	4.5		X Walk 2 Slope (%)	1.9
	X Walk 1 X Slope (%)	2.7		X Walk 2 X Slope (%)	3.4

N/A	Ramp inside XWalk1?	N/A	N/A	Ramp inside XWalk2?	N/A
	Road Slope (%)	1.3	N/A	Clear Space?	Yes
	Road X Slope (%)	7.9	N/A	Clear Space to XWalk (in)	N/A
Yes	Any Obstructions?	No	Yes	Storm Grate/Utility Hazard?	No
	Obstruction Type			Storm Grate/Utility Type	
		N/A			N/A
			Yes	Surface Condition? (G/P)	Good

Remove & Replace Curb Ramp With Two New Directional Ramps or Equivalent.

Total Cost: \$ 3200.00
