# Access Compliance Report

## Public Rights-of-Way

### (Curb Ramps)

Intersection ID: 30049	Main Street: SUMMER_COACH_DR	Cross Street: SUNSET_VILLAGE_DR	Location: SW
ADA ID: B7AE8E867CD4	Ramp Type: PerpDiag	Initial Pass/Fail: Fail	Overall Compliance: No
Severity Score: 21.25			
Codes/Mitigation Info/Possible Solution		Field Measurements/Component Compliance

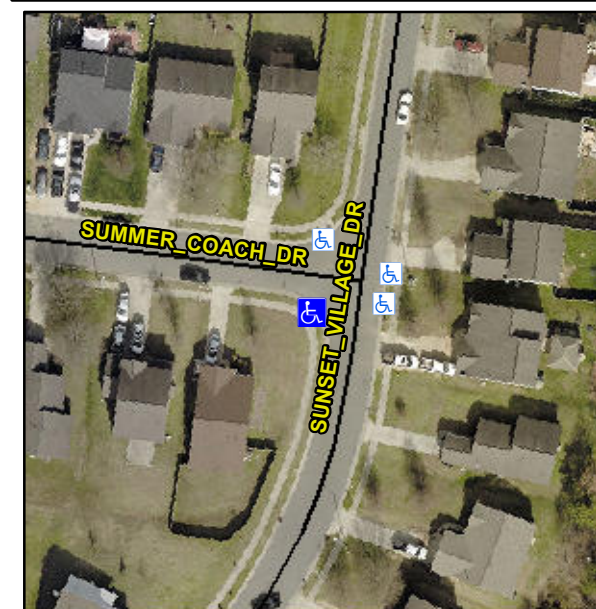
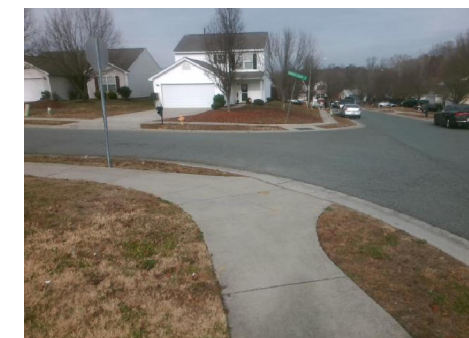
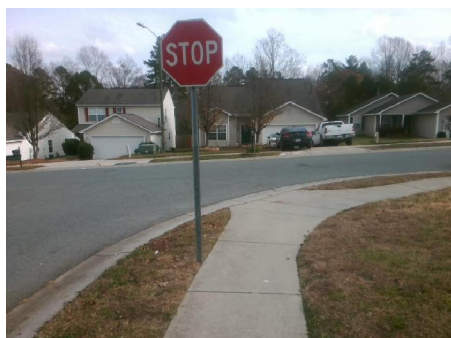
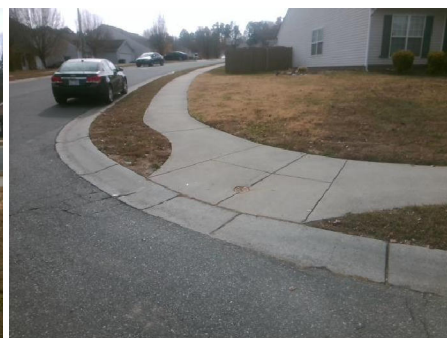
Compliance	Description	Data	Compliance	Description	Data
N/A	Ramp Length (in)	94.5	Yes	Ramp Slope (%)	8.0
No	Ramp Width (in)	37.0	No	Ramp XSlope (%)	6.0
N/A	Flare Type LT	N/A	N/A	Flare Type RT	N/A
N/A	Flare Slope LT (%)	N/A	N/A	Flare Slope RT (%)	N/A
N/A	Flare Traversable LT?	N/A	N/A	Flare Traversable RT?	N/A
N/A	Landing Length (in)	N/A	N/A	DWS Provided?	N/A
N/A	Landing Width (in)	N/A	N/A	DWS Contrast?	N/A
N/A	Landing Slope (%)	N/A	N/A	DWS Length (in)	N/A
N/A	Landing X Slope (%)	N/A	N/A	DWS Full Width?	N/A
N/A	Landing Curb? (Y/N)	N/A	N/A	DWS Offset (in)	N/A
N/A	Shared Landing?	N/A			
N/A	Gutter Ponding?	N/A	N/A	Gutter Slope (%)	N/A
N/A	Gutter Lip Ht (in)	N/A	N/A	Gutter X Slope (%)	N/A
N/A	Painted X Walk1?	No	N/A	Painted X Walk2?	No
	X Walk 1 Direction	To E		X Walk 2 Direction	To NE
N/A	X Walk 1 Width (in)	N/A	N/A	X Walk 2 Width (in)	N/A
	X Walk 1 Slope (%)	3.5		X Walk 2 Slope (%)	1.2
	X Walk 1 X Slope (%)	0.3		X Walk 2 X Slope (%)	1.6

N/A	Ramp inside XWalk1?	N/A	N/A	Ramp inside XWalk2?	N/A
	Road Slope (%)	3.1	N/A	Clear Space?	N/A
	Road X Slope (%)	2.5	N/A	Clear Space to XWalk (in)	N/A
N/A	Any Obstructions?	N/A	N/A	Storm Grate/Utility Hazard?	N/A
	Obstruction Type			Storm Grate/Utility Type	
		N/A			N/A
			Yes	Surface Condition? (G/P)	Good

**Remove & Replace Curb Ramp With Two New Directional Ramps or Equivalent.**

**R304.5.1, R304.5.3**
