# Access Compliance Report

## Public Rights-of-Way

### (Curb Ramps)

Intersection ID: 49389	Main Street: AUBRAC_LN	Cross Street: SHORTHORN_ST	Location: NW
ADA ID: B7B416F995C8	Ramp Type: PerpDiag	Initial Pass/Fail: Fail	Overall Compliance: No
Severity Score: 22.5			
Codes/Mitigation Info/Possible Solution		Field Measurements/Component Compliance

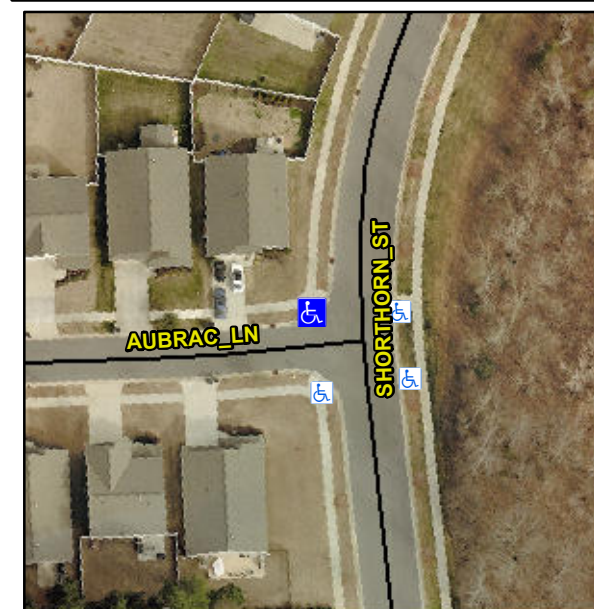
**R304.5.1, R304.2.2, R304.5.3**

Compliance	Description	Data	Compliance	Description	Data
N/A	Ramp Length (in)	75.0	No	Ramp Slope (%)	11.7
No	Ramp Width (in)	47.5	No	Ramp XSlope (%)	3.1
N/A	Flare Type LT	N/A	N/A	Flare Type RT	N/A
N/A	Flare Slope LT (%)	N/A	N/A	Flare Slope RT (%)	N/A
N/A	Flare Traversable LT?	N/A	N/A	Flare Traversable RT?	N/A
N/A	Landing Length (in)	N/A	N/A	DWS Provided?	N/A
N/A	Landing Width (in)	N/A	N/A	DWS Contrast?	N/A
N/A	Landing Slope (%)	N/A	N/A	DWS Length (in)	N/A
N/A	Landing X Slope (%)	N/A	N/A	DWS Full Width?	N/A
N/A	Landing Curb? (Y/N)	N/A	N/A	DWS Offset (in)	N/A
N/A	Shared Landing?	N/A			
N/A	Gutter Ponding?	N/A	N/A	Gutter Slope (%)	N/A
N/A	Gutter Lip Ht (in)	N/A	N/A	Gutter X Slope (%)	N/A
N/A	Painted X Walk1?	No	N/A	Painted X Walk2?	No
	X Walk 1 Direction	To S		X Walk 2 Direction	To E
N/A	X Walk 1 Width (in)	N/A	N/A	X Walk 2 Width (in)	N/A
	X Walk 1 Slope (%)	1.4		X Walk 2 Slope (%)	2.1
	X Walk 1 X Slope (%)	2.1		X Walk 2 X Slope (%)	2.8

N/A	Ramp inside XWalk1?	N/A	N/A	Ramp inside XWalk2?	N/A
	Road Slope (%)	4.0	N/A	Clear Space?	N/A
	Road X Slope (%)	1.8	N/A	Clear Space to XWalk (in)	N/A
N/A	Any Obstructions?	N/A	N/A	Storm Grate/Utility Hazard?	N/A
	Obstruction Type			Storm Grate/Utility Type	
		N/A			N/A
			Yes	Surface Condition? (G/P)	Good

**Remove & Replace Curb Ramp With Two New Directional Ramps or Equivalent.**
