Access Compliance Report

Public Rights-of-Way

(Curb Ramps)

Intersection ID: 18109	Main Street: DREXEL_PL	Cross Street: PARK_RD	Location: NW
ADA ID: B7B94CC67B99	Ramp Type: ParaDiag	Initial Pass/Fail: Fail	Overall Compliance: No
		Severity Score: 12.5

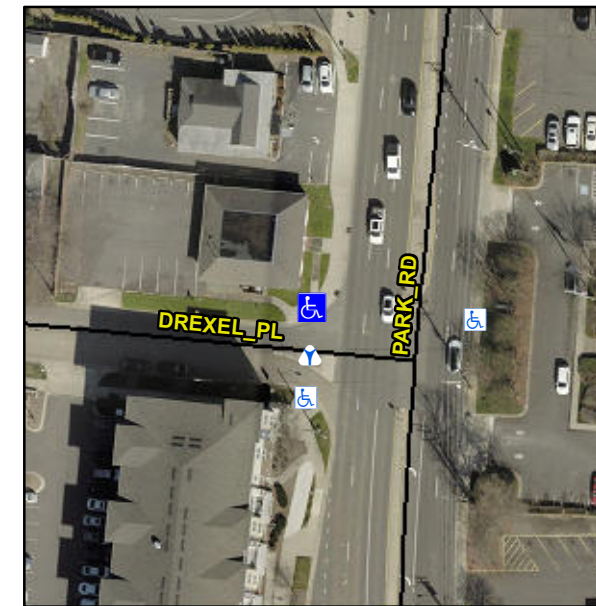
LT RP < 5%

R304.3.2

Compliance	Description	Data	Compliance	Description	Data
N/A	Ramp Length LT (in)	54.0	N/A	Ramp Length RT (in)	62.0
Yes	Ramp Width LT (in)	83.0	Yes	Ramp Width RT (in)	83.0
Yes	Ramp Slope LT (%)	0.2	No	Ramp Slope RT (%)	9.7
Yes	Ramp XSlope LT (%)	0.3	Yes	Ramp XSlope RT (%)	0.7
N/A	Landing Length (in)	N/A	N/A	DWS Provided?	N/A
N/A	Landing Width (in)	N/A	N/A	DWS Contrast?	N/A
N/A	Landing Slope (%)	N/A	N/A	DWS Length (in)	N/A
N/A	Landing X Slope (%)	N/A	N/A	DWS Full Width?	N/A
N/A	Landing Curb? (Y/N)	N/A	N/A	DWS Offset (in)	N/A
N/A	Shared Landing?	N/A			
N/A	Gutter Ponding?	N/A	N/A	Gutter Slope (%)	N/A
N/A	Gutter Lip Ht (in)	N/A	N/A	Gutter X Slope (%)	N/A
N/A	Painted X Walk1?	No	N/A	Painted X Walk2?	No
	X Walk 1 Direction	To S		X Walk 2 Direction	To E
N/A	X Walk 1 Width (in)	N/A	N/A	X Walk 2 Width (in)	N/A
	X Walk 1 Slope (%)	0.2		X Walk 2 Slope (%)	2.7
	X Walk 1 X Slope (%)	3.7		X Walk 2 X Slope (%)	1.2
N/A	Ramp inside XWalk1?	N/A	N/A	Ramp inside XWalk2?	N/A

Road Slope (%)	2.8	N/A	Clear Space?	N/A
	Road X Slope (%)	1.4	N/A	Clear Space to XWalk (in)	N/A
N/A	Any Obstructions?	N/A	N/A	Storm Grate/Utility Hazard?	N/A
	Obstruction Type			Storm Grate/Utility Type	
		N/A			N/A
			Yes	Surface Condition? (G/P)	Good
			N/A	Curb Slope (%)	7.9

Remove & Replace Curb Ramp With Two New Directional Ramps or Equivalent.
