# Access Compliance Report

## Public Rights-of-Way (Curb Ramps)

Intersection ID: 51314	Main Street: W_W_T_HARRIS_BV	Cross Street: I-485_RA	Location: SW
ADA ID: B7BD80F2C8EF	Ramp Type: Perp	Initial Pass/Fail: Fail	Overall Compliance: No
Severity Score: 21.25			
Codes/Mitigation Info/Possible Solution		Field Measurements/Component Compliance

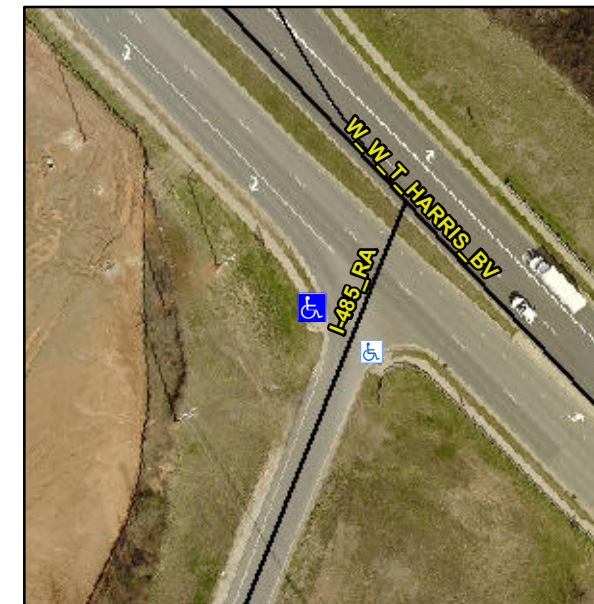
**Not Found, R304.5.1, R304.2.2**

Compliance	Description	Data	Compliance	Description	Data
N/A	Ramp Length (in)	88.0	No	Ramp Slope (%)	8.4
No	Ramp Width (in)	47.0	Yes	Ramp XSlope (%)	2.0
N/A	Flare Type LT	N/A	N/A	Flare Type RT	N/A
N/A	Flare Slope LT (%)	N/A	N/A	Flare Slope RT (%)	N/A
N/A	Flare Traversable LT?	N/A	N/A	Flare Traversable RT?	N/A
N/A	Landing Length (in)	N/A	N/A	DWS Provided?	N/A
N/A	Landing Width (in)	N/A	N/A	DWS Contrast?	N/A
N/A	Landing Slope (%)	N/A	N/A	DWS Length (in)	N/A
N/A	Landing X Slope (%)	N/A	N/A	DWS Full Width?	N/A
N/A	Landing Curb? (Y/N)	N/A	N/A	DWS Offset (in)	N/A
N/A	Shared Landing?	N/A			
N/A	Gutter Ponding?	N/A	N/A	Gutter Slope (%)	N/A
N/A	Gutter Lip Ht (in)	N/A	N/A	Gutter X Slope (%)	N/A
N/A	Painted X Walk1?	No	N/A	Painted X Walk2?	N/A
	X Walk 1 Direction	To SE		X Walk 2 Direction	N/A
N/A	X Walk 1 Width (in)	N/A	N/A	X Walk 2 Width (in)	N/A
	X Walk 1 Slope (%)	2.5		X Walk 2 Slope (%)	N/A
	X Walk 1 X Slope (%)	2.8		X Walk 2 X Slope (%)	N/A

N/A	Ramp inside XWalk1?	N/A	N/A	Ramp inside XWalk2?	N/A
	Road Slope (%)	N/A	N/A	Clear Space?	N/A
	Road X Slope (%)	N/A	N/A	Clear Space to XWalk (in)	N/A
N/A	Any Obstructions?	N/A	N/A	Storm Grate/Utility Hazard?	N/A
	Obstruction Type			Storm Grate/Utility Type	
		N/A			N/A
			Yes	Surface Condition? (G/P)	Good

**Remove & Replace Entire Ramp.**
