Access Compliance Report

Public Rights-of-Way

(Curb Ramps)

Intersection ID: 3034	Main Street: JUNE WILLIAM LN	Cross Street: JOHNSTON OEHLER RD	Location: E
ADA ID: B7C9125E68C5	Ramp Type: Perp	Initial Pass/Fail: Fail	Overall Compliance: No
Severity Score: 13.75			
Codes/Mitigation Info/Possible Solution		Field Measurements/Component Compliance

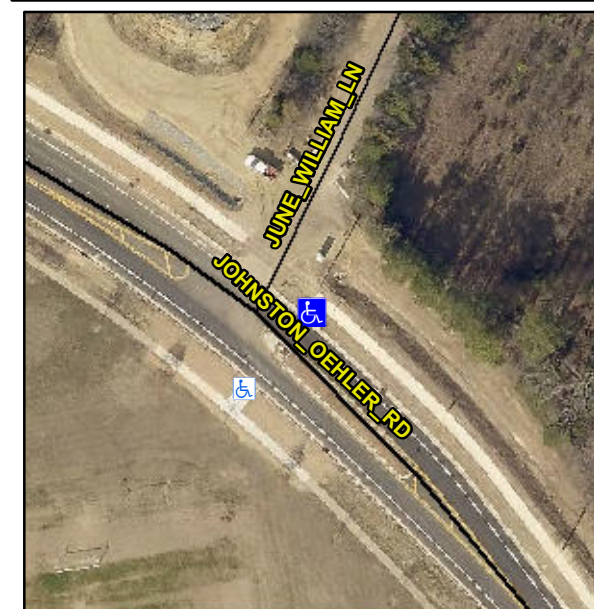
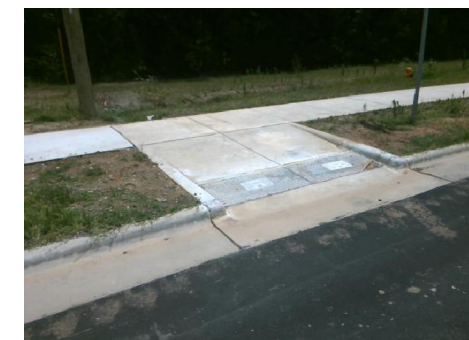
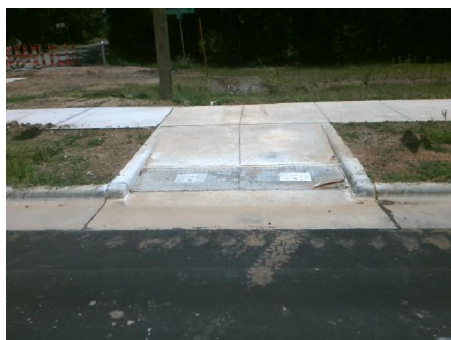
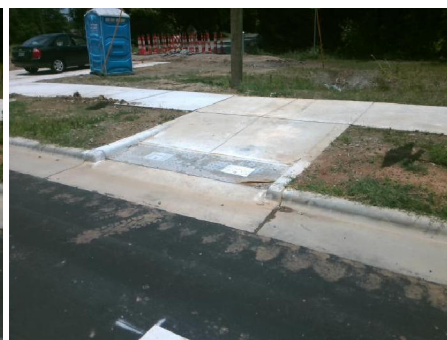
R304.2.2, R304.5.3

Compliance	Description	Data	Compliance	Description	Data
N/A	Ramp Length (in)	96.0	No	Ramp Slope (%)	9.4
Yes	Ramp Width (in)	94.0	No	Ramp XSlope (%)	2.2
N/A	Flare Type LT	N/A	N/A	Flare Type RT	N/A
N/A	Flare Slope LT (%)	N/A	N/A	Flare Slope RT (%)	N/A
N/A	Flare Traversable LT?	N/A	N/A	Flare Traversable RT?	N/A
N/A	Landing Length (in)	N/A	N/A	DWS Provided?	N/A
N/A	Landing Width (in)	N/A	N/A	DWS Contrast?	N/A
N/A	Landing Slope (%)	N/A	N/A	DWS Length (in)	N/A
N/A	Landing X Slope (%)	N/A	N/A	DWS Full Width?	N/A
N/A	Landing Curb? (Y/N)	N/A	N/A	DWS Offset (in)	N/A
N/A	Shared Landing?	N/A			
N/A	Gutter Ponding?	N/A	N/A	Gutter Slope (%)	N/A
N/A	Gutter Lip Ht (in)	N/A	N/A	Gutter X Slope (%)	N/A
N/A	Painted X Walk1?	No	N/A	Painted X Walk2?	N/A
	X Walk 1 Direction	To SW		X Walk 2 Direction	N/A
N/A	X Walk 1 Width (in)	N/A	N/A	X Walk 2 Width (in)	N/A
	X Walk 1 Slope (%)	2.8		X Walk 2 Slope (%)	N/A
	X Walk 1 X Slope (%)	1.3		X Walk 2 X Slope (%)	N/A

N/A	Ramp inside XWalk1?	N/A	N/A	Ramp inside XWalk2?	N/A
	Road Slope (%)	N/A	N/A	Clear Space?	N/A
	Road X Slope (%)	N/A	N/A	Clear Space to XWalk (in)	N/A
N/A	Any Obstructions?	N/A	N/A	Storm Grate/Utility Hazard?	N/A
	Obstruction Type			Storm Grate/Utility Type	
		N/A			N/A
			Yes	Surface Condition? (G/P)	Good

Remove & Replace Entire Ramp.
