Access Compliance Report

Public Rights-of-Way

(Curb Ramps)

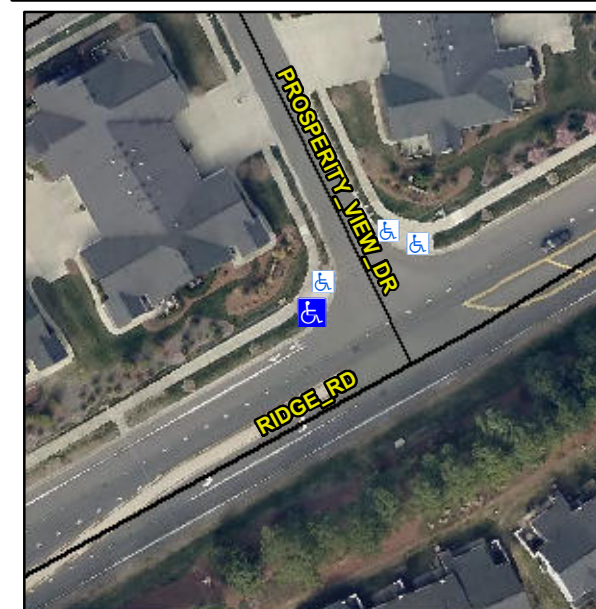
Intersection ID: 43362	Main Street: PROSPERITY_VIEW_DR	Cross Street: RIDGE_RD	Location: NW
ADA ID: B7D332994D92	Ramp Type: Perp	Initial Pass/Fail: Fail	Overall Compliance: No
Severity Score: 8.75			
Codes/Mitigation Info/Possible Solution		Field Measurements/Component Compliance

PROW/ADA:

R304.5.1

Compliance	Description	Data	Compliance	Description	Data
N/A	Ramp Length (in)	109.0	Yes	Ramp Slope (%)	6.4
No	Ramp Width (in)	47.0	Yes	Ramp XSlope (%)	0.1
N/A	Flare Type LT	N/A	N/A	Flare Type RT	N/A
N/A	Flare Slope LT (%)	N/A	N/A	Flare Slope RT (%)	N/A
N/A	Flare Traversable LT?	N/A	N/A	Flare Traversable RT?	N/A
N/A	Landing Length (in)	N/A	N/A	DWS Provided?	N/A
N/A	Landing Width (in)	N/A	N/A	DWS Contrast?	N/A
N/A	Landing Slope (%)	N/A	N/A	DWS Length (in)	N/A
N/A	Landing X Slope (%)	N/A	N/A	DWS Full Width?	N/A
N/A	Landing Curb? (Y/N)	N/A	N/A	DWS Offset (in)	N/A
N/A	Shared Landing?	N/A			
N/A	Gutter Ponding?	N/A	N/A	Gutter Slope (%)	N/A
N/A	Gutter Lip Ht (in)	N/A	N/A	Gutter X Slope (%)	N/A
N/A	Painted X Walk1?	No	N/A	Painted X Walk2?	N/A
	X Walk 1 Direction	To S		X Walk 2 Direction	N/A
N/A	X Walk 1 Width (in)	N/A	N/A	X Walk 2 Width (in)	N/A
	X Walk 1 Slope (%)	0.7		X Walk 2 Slope (%)	N/A
	X Walk 1 X Slope (%)	1.6		X Walk 2 X Slope (%)	N/A

Possible Solutions:

Remove & Replace Entire Ramp.
