Access Compliance Report

Public Rights-of-Way

(Curb Ramps)

Intersection ID: 13418	Main Street: SOUTHWOOD_AV	Cross Street: WESTWOOD_AV	Location:	N
ADA ID: B7D43AC6282B	Ramp Type: PerpDiag	Initial Pass/Fail: Fail	Overall Compliance: No	Severity Score: 12.5
Codes/Mitigation Info/Possible Solution		Field Measurements/Component Compliance

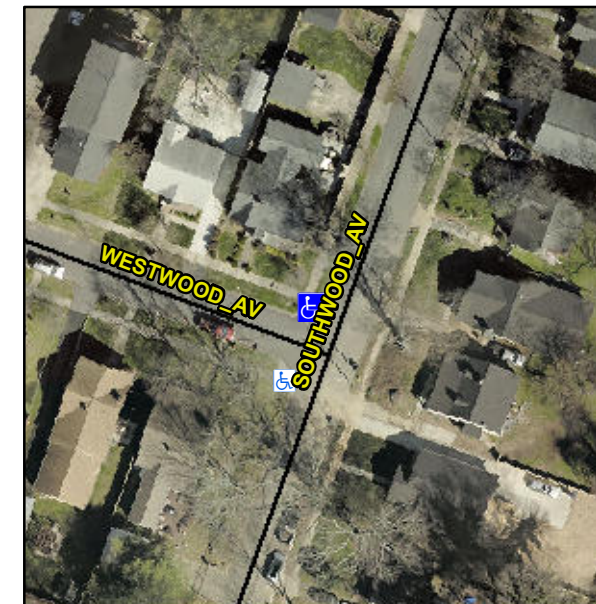
Compliance	Description	Data	Compliance	Description	Data
N/A	Ramp Length (in)	99.0	Yes	Ramp Slope (%)	7.1
Yes	Ramp Width (in)	72.0	No	Ramp XSlope (%)	5.6
N/A	Flare Type LT	N/A	N/A	Flare Type RT	N/A
N/A	Flare Slope LT (%)	N/A	N/A	Flare Slope RT (%)	N/A
N/A	Flare Traversable LT?	N/A	N/A	Flare Traversable RT?	N/A
N/A	Landing Length (in)	N/A	N/A	DWS Provided?	N/A
N/A	Landing Width (in)	N/A	N/A	DWS Contrast?	N/A
N/A	Landing Slope (%)	N/A	N/A	DWS Length (in)	N/A
N/A	Landing X Slope (%)	N/A	N/A	DWS Full Width?	N/A
N/A	Landing Curb? (Y/N)	N/A	N/A	DWS Offset (in)	N/A
N/A	Shared Landing?	N/A			
N/A	Gutter Ponding?	N/A	N/A	Gutter Slope (%)	N/A
N/A	Gutter Lip Ht (in)	N/A	N/A	Gutter X Slope (%)	N/A
N/A	Painted X Walk1?	No	N/A	Painted X Walk2?	No
	X Walk 1 Direction	To SW		X Walk 2 Direction	To SE
N/A	X Walk 1 Width (in)	N/A	N/A	X Walk 2 Width (in)	N/A
	X Walk 1 Slope (%)	0.9		X Walk 2 Slope (%)	8.3
	X Walk 1 X Slope (%)	4.9		X Walk 2 X Slope (%)	2.3

N/A	Ramp inside XWalk1?	N/A	N/A	Ramp inside XWalk2?	N/A
	Road Slope (%)	7.1	N/A	Clear Space?	N/A
	Road X Slope (%)	8.6	N/A	Clear Space to XWalk (in)	N/A
N/A	Any Obstructions?	N/A	N/A	Storm Grate/Utility Hazard?	N/A
	Obstruction Type			Storm Grate/Utility Type	
		N/A			N/A
		Yes		Surface Condition? (G/P)	Good

Possible Solutions:

Remove & Replace Curb Ramp With Two New Directional Ramps or Equivalent.

R304.5.3
