# Access Compliance Report

## Public Rights-of-Way

### (Curb Ramps)

Intersection ID: 19143	Main Street: EDMONT_RD	Cross Street: PROVIDENCE_RD	Location: SW
ADA ID: B7DAB69382DD	Ramp Type: ParaDiag	Initial Pass/Fail: Fail	Overall Compliance: No
			Severity Score: 18.75

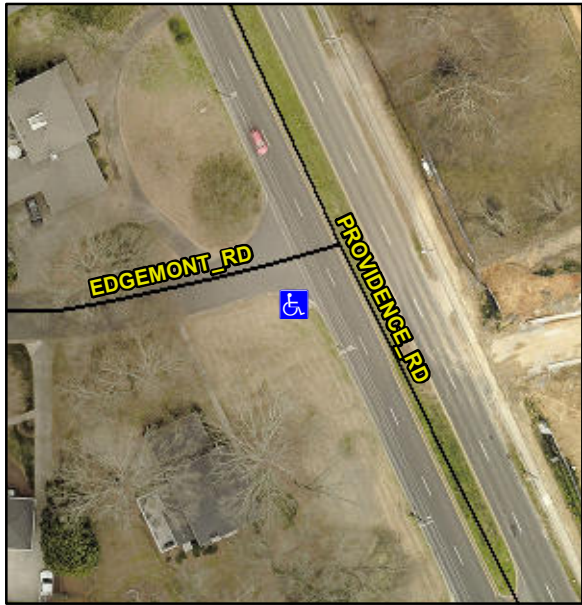
Possible Solutions:		Compliance	Description	Data	Compliance	Description	Data
	<b>Remove &amp; Replace Curb Ramp With Two New Directional Ramps or Equivalent.</b>		N/A	Ramp Length LT (in)	59.0	N/A	Ramp Length RT (in)	60.0
			No	Ramp Width LT (in)	33.0	No	Ramp Width RT (in)	33.0
			Yes	Ramp Slope LT (%)	5.2	Yes	Ramp Slope RT (%)	7.4
			No	Ramp XSlope LT (%)	2.8	No	Ramp XSlope RT (%)	4.3
			N/A	Landing Length (in)	N/A	N/A	DWS Provided?	N/A
			N/A	Landing Width (in)	N/A	N/A	DWS Contrast?	N/A
			N/A	Landing Slope (%)	N/A	N/A	DWS Length (in)	N/A
			N/A	Landing X Slope (%)	N/A	N/A	DWS Full Width?	N/A
			N/A	Landing Curb? (Y/N)	N/A	N/A	DWS Offset (in)	N/A
Surveyor Notes:			N/A	Shared Landing?	N/A			
PROW/ADA:			N/A	Gutter Ponding?	N/A	N/A	Gutter Slope (%)	N/A
<b>R304.5.1, R304.5.3</b>			N/A	Gutter Lip Ht (in)	N/A	N/A	Gutter X Slope (%)	N/A

N/A	Painted X Walk1?	No	N/A	Painted X Walk2?	No
				X Walk 1 Direction	To NE		X Walk 2 Direction	To NW
			N/A	X Walk 1 Width (in)	N/A	N/A	X Walk 2 Width (in)	N/A
				X Walk 1 Slope (%)	1.4		X Walk 2 Slope (%)	5.3
				X Walk 1 X Slope (%)	3.4		X Walk 2 X Slope (%)	0.0
			N/A	Ramp inside XWalk1?	N/A	N/A	Ramp inside XWalk2?	N/A
				Road Slope (%)	1.4	N/A	Clear Space?	N/A
				Road X Slope (%)	5.2	N/A	Clear Space to XWalk (in)	N/A
			N/A	Any Obstructions?	N/A	N/A	Storm Grate/Utility Hazard?	N/A
				Obstruction Type			Storm Grate/Utility Type	
					N/A			N/A
						Yes	Surface Condition? (G/P)	Good
						N/A	Curb Slope (%)	12.9
Total Cost:		\$	3200.00					
Street 1 Name		PROVIDENCE RD						
Stop Condition-Street 1		None						
Street 2 Name		EDGEMONT RD						
Stop Condition-Street 2		StopSign
