# Access Compliance Report

## Public Rights-of-Way

### (Curb Ramps)

Intersection ID: 14132	Main Street: LEXINGTON_AV	Cross Street: MT_VERNON_AV	Location: SE
ADA ID: B7E3A340EAA9	Ramp Type: Directional1	Initial Pass/Fail: Fail	Overall Compliance: No
			Severity Score: 21.25

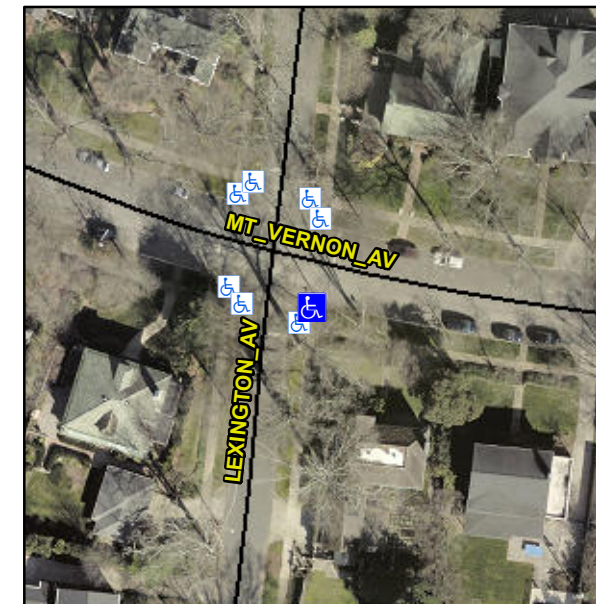
Compliance	Description	Data	Compliance	Description	Data
N/A	Ramp Length (in)	33.0	N/A	Grade Break?	N/A
No	Ramp Width (in)	36.0	N/A	Grade Break Slope (%)	0.0
No	Ramp Slope (%)	8.5	N/A	Grade Break XSlope (%)	0.0
Yes	Ramp XSlope (%)	1.4			
N/A	Flare Type LT	N/A	N/A	Flare Type RT	N/A
N/A	Flare Slope LT (%)	N/A	N/A	Flare Slope RT (%)	0.0
N/A	Flare Traversable LT?	N/A	N/A	Flare Traversable RT?	N/A
N/A	Landing Length (in)	0.0	N/A	DWS Provided?	N/A
N/A	Landing Width (in)	0.0	N/A	DWS Contrast?	N/A
N/A	Landing Slope (%)	0.0	N/A	DWS Length (in)	N/A
N/A	Landing X Slope (%)	0.0	N/A	DWS Full Width?	N/A
N/A	Landing Curb? (Y/N)	N/A	N/A	DWS Offset LT (in)	N/A
N/A	Shared Landing?	N/A	N/A	DWS Offset RT (in)	N/A
N/A	Gutter Ponding?	0.0	N/A	Gutter Slope (%)	N/A
N/A	Gutter Lip Ht (in)	0.0	N/A	Gutter X Slope (%)	N/A
N/A	Painted X Walk1?	No		Road Slope (%)	1.0
	X Walk 1 Direction	To N		Road X Slope (%)	1.3
	X Walk 1 Width (in)	N/A		Clear Space?	N/A

X Walk 1 Slope (%)	1.0	N/A	Clear Space to XWalk (in)	N/A
	X Walk 1 X Slope (%)	1.3	N/A	Storm Grate/Utility Hazard?	N/A
N/A	Ramp inside XWalk1?	N/A		Storm Grate/Utility Type	
N/A	Any Obstructions?	N/A			N/A
	Obstruction Type		Yes	Surface Condition? (G/P)	Good
			N/A	Curb Slope (%)	8.9

**Remove & Replace Entire Ramp.**

**R304.5.1, R304.2.2**
