Access Compliance Report

Public Rights-of-Way

(Curb Ramps)

Intersection ID: 12380	Main Street: GREAT_WAGON_RD	Cross Street: SHAMROCK_DR	Location: SW
ADA ID: B7E6C241C47A	Ramp Type: Perp	Initial Pass/Fail: Fail	Overall Compliance: No
			Severity Score: 21.25

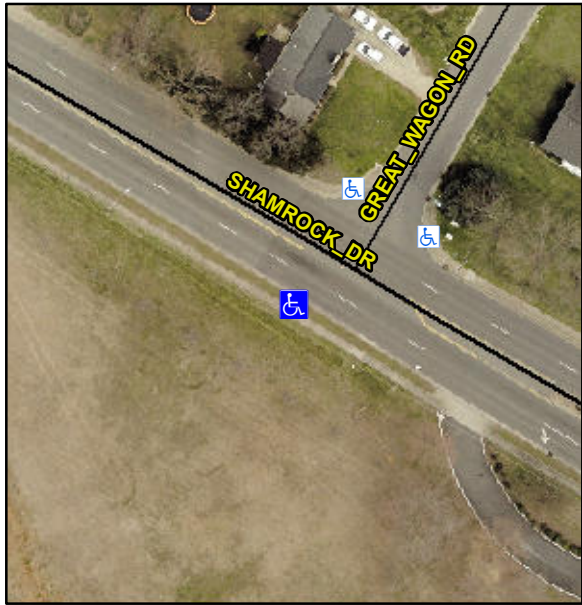
Possible Solutions:		Compliance	Description	Data	Compliance	Description	Data
	Remove & Replace Entire Ramp.		N/A	Ramp Length (in)	47.5	No	Ramp Slope (%)	9.7
			No	Ramp Width (in)	44.0	Yes	Ramp XSlope (%)	1.7
			N/A	Flare Type LT	N/A	N/A	Flare Type RT	N/A
			N/A	Flare Slope LT (%)	N/A	N/A	Flare Slope RT (%)	N/A
			N/A	Flare Traversable LT?	N/A	N/A	Flare Traversable RT?	N/A
			N/A	Landing Length (in)	N/A	N/A	DWS Provided?	N/A
			N/A	Landing Width (in)	N/A	N/A	DWS Contrast?	N/A
			N/A	Landing Slope (%)	N/A	N/A	DWS Length (in)	N/A
			N/A	Landing X Slope (%)	N/A	N/A	DWS Full Width?	N/A
Surveyor Notes:			N/A	Landing Curb? (Y/N)	N/A	N/A	DWS Offset (in)	N/A
N/A			N/A	Shared Landing?	N/A			
PROW/ADA:			N/A	Gutter Ponding?	N/A	N/A	Gutter Slope (%)	N/A
Not Found, R304.5.1, R304.2.2			N/A	Gutter Lip Ht (in)	N/A	N/A	Gutter X Slope (%)	N/A

N/A	Painted X Walk1?	No	N/A	Painted X Walk2?	N/A
				X Walk 1 Direction	To NE		X Walk 2 Direction	N/A
			N/A	X Walk 1 Width (in)	N/A	N/A	X Walk 2 Width (in)	N/A
				X Walk 1 Slope (%)	1.6		X Walk 2 Slope (%)	N/A
				X Walk 1 X Slope (%)	2.8		X Walk 2 X Slope (%)	N/A
			N/A	Ramp inside XWalk1?	N/A	N/A	Ramp inside XWalk2?	N/A
				Road Slope (%)	N/A	N/A	Clear Space?	N/A
				Road X Slope (%)	N/A	N/A	Clear Space to XWalk (in)	N/A
			N/A	Any Obstructions?	N/A	N/A	Storm Grate/Utility Hazard?	N/A
				Obstruction Type			Storm Grate/Utility Type	
						N/A		N/A
						Yes	Surface Condition? (G/P)	Good
Total Cost:		\$ 1850.00
