# Access Compliance Report

## Public Rights-of-Way

### (Curb Ramps)

Intersection ID: 13620	Main Street: SHENANDOAH_AV	Cross Street: THE_PLAZA	Location: S
ADA ID: B7E812A50D72	Ramp Type: PerpDiag	Initial Pass/Fail: Fail	Overall Compliance: No
Codes/Mitigation Info/Possible Solution			Severity Score: 25
			Field Measurements/Component Compliance

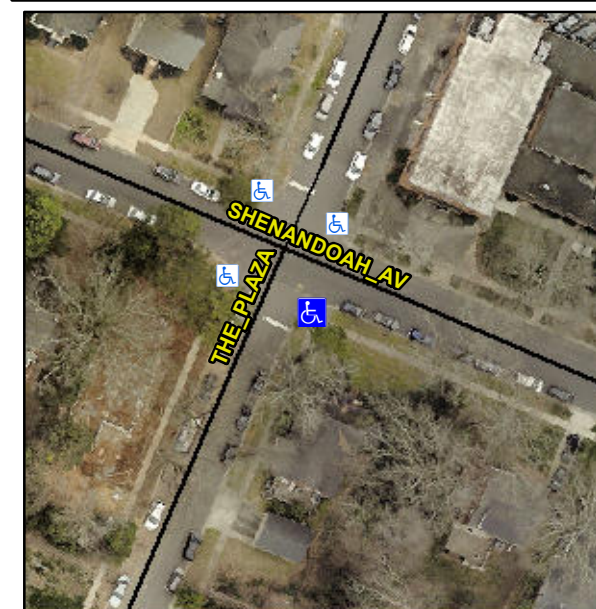
**Not Found, R304.2.2, R304.5.3**

Compliance	Description	Data	Compliance	Description	Data
N/A	Ramp Length (in)	92.0	No	Ramp Slope (%)	8.8
Yes	Ramp Width (in)	48.0	No	Ramp XSlope (%)	5.1
N/A	Flare Type LT	N/A	N/A	Flare Type RT	N/A
N/A	Flare Slope LT (%)	N/A	N/A	Flare Slope RT (%)	N/A
N/A	Flare Traversable LT?	N/A	N/A	Flare Traversable RT?	N/A
N/A	Landing Length (in)	N/A	N/A	DWS Provided?	N/A
N/A	Landing Width (in)	N/A	N/A	DWS Contrast?	N/A
N/A	Landing Slope (%)	N/A	N/A	DWS Length (in)	N/A
N/A	Landing X Slope (%)	N/A	N/A	DWS Full Width?	N/A
N/A	Landing Curb? (Y/N)	N/A	N/A	DWS Offset (in)	N/A
N/A	Shared Landing?	N/A			
N/A	Gutter Ponding?	N/A	N/A	Gutter Slope (%)	N/A
N/A	Gutter Lip Ht (in)	N/A	N/A	Gutter X Slope (%)	N/A
N/A	Painted X Walk1?	No	N/A	Painted X Walk2?	No
	X Walk 1 Direction	To NE		X Walk 2 Direction	To NW
N/A	X Walk 1 Width (in)	N/A	N/A	X Walk 2 Width (in)	N/A
	X Walk 1 Slope (%)	6.3		X Walk 2 Slope (%)	0.2
	X Walk 1 X Slope (%)	2.6		X Walk 2 X Slope (%)	5.5

N/A	Ramp inside XWalk1?	N/A	N/A	Ramp inside XWalk2?	N/A
	Road Slope (%)	5.3	N/A	Clear Space?	N/A
	Road X Slope (%)	3.3	N/A	Clear Space to XWalk (in)	N/A
N/A	Any Obstructions?	N/A	N/A	Storm Grate/Utility Hazard?	N/A
	Obstruction Type			Storm Grate/Utility Type	
		N/A			N/A
			Yes	Surface Condition? (G/P)	Good

**Remove & Replace Curb Ramp With Two New Directional Ramps or Equivalent.**
