Access Compliance Report

Public Rights-of-Way

(Curb Ramps)

Intersection ID: 49656	Main Street: SKYLINE_VIEW_WY	Cross Street: SEIGLE_POINT_DR	Location: S
ADA ID: B7E9EE140C8A	Ramp Type: Perp	Initial Pass/Fail: Fail	Overall Compliance: No
Severity Score: 12.5			
Codes/Mitigation Info/Possible Solution		Field Measurements/Component Compliance

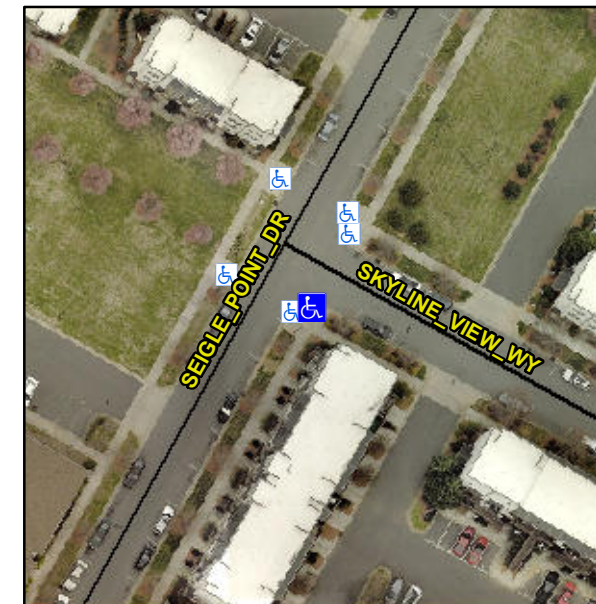
Not Found, R304.2.2

Compliance	Description	Data	Compliance	Description	Data
N/A	Ramp Length (in)	67.5	No	Ramp Slope (%)	8.4
Yes	Ramp Width (in)	74.0	Yes	Ramp XSlope (%)	0.1
N/A	Flare Type LT	N/A	N/A	Flare Type RT	N/A
N/A	Flare Slope LT (%)	N/A	N/A	Flare Slope RT (%)	N/A
N/A	Flare Traversable LT?	N/A	N/A	Flare Traversable RT?	N/A
N/A	Landing Length (in)	N/A	N/A	DWS Provided?	N/A
N/A	Landing Width (in)	N/A	N/A	DWS Contrast?	N/A
N/A	Landing Slope (%)	N/A	N/A	DWS Length (in)	N/A
N/A	Landing X Slope (%)	N/A	N/A	DWS Full Width?	N/A
N/A	Landing Curb? (Y/N)	N/A	N/A	DWS Offset (in)	N/A
N/A	Shared Landing?	N/A			
N/A	Gutter Ponding?	N/A	N/A	Gutter Slope (%)	N/A
N/A	Gutter Lip Ht (in)	N/A	N/A	Gutter X Slope (%)	N/A
N/A	Painted X Walk1?	No	N/A	Painted X Walk2?	N/A
	X Walk 1 Direction	To NE		X Walk 2 Direction	N/A
N/A	X Walk 1 Width (in)	N/A	N/A	X Walk 2 Width (in)	N/A
	X Walk 1 Slope (%)	3.3		X Walk 2 Slope (%)	N/A
	X Walk 1 X Slope (%)	1.1		X Walk 2 X Slope (%)	N/A

N/A	Ramp inside XWalk1?	N/A	N/A	Ramp inside XWalk2?	N/A
	Road Slope (%)	N/A	N/A	Clear Space?	N/A
	Road X Slope (%)	N/A	N/A	Clear Space to XWalk (in)	N/A
N/A	Any Obstructions?	N/A	N/A	Storm Grate/Utility Hazard?	N/A
	Obstruction Type			Storm Grate/Utility Type	
		N/A			N/A
			Yes	Surface Condition? (G/P)	Good

Possible Solutions:

Remove & Replace Entire Ramp.

Total Cost: \$ 1850.00
