# Access Compliance Report

## Public Rights-of-Way

### (Curb Ramps)

Intersection ID: 46785	Main Street: DOMINION_VILLAGE_DR	Cross Street: AUTUMN_HARVEST_LN	Location: S
ADA ID: B7F2380EE910	Ramp Type: PerpDiag	Initial Pass/Fail: Fail	Overall Compliance: No
Codes/Mitigation Info/Possible Solution		Field Measurements/Component Compliance	
Severity Score: 10

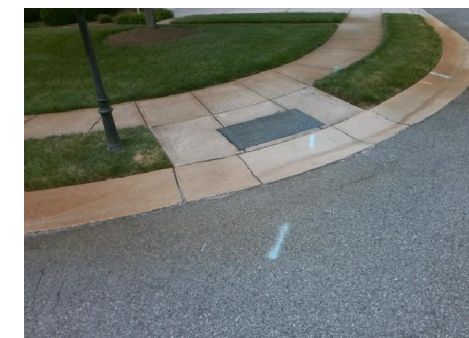
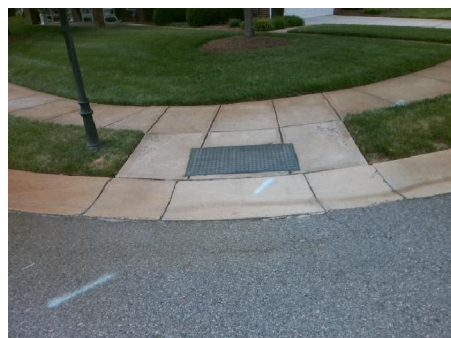
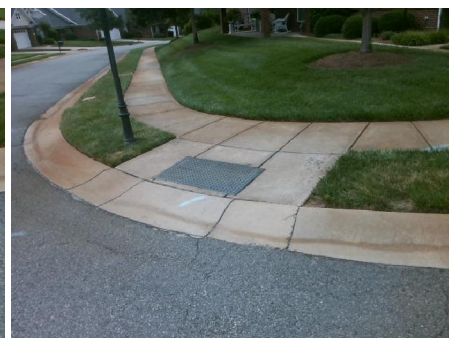
Compliance	Description	Data	Compliance	Description	Data
N/A	Ramp Length (in)	48.0	Yes	Ramp Slope (%)	5.3
No	Ramp Width (in)	36.0	No	Ramp XSlope (%)	2.8
N/A	Flare Type LT	N/A	N/A	Flare Type RT	N/A
N/A	Flare Slope LT (%)	N/A	N/A	Flare Slope RT (%)	N/A
N/A	Flare Traversable LT?	N/A	N/A	Flare Traversable RT?	N/A
N/A	Landing Length (in)	N/A	N/A	DWS Provided?	N/A
N/A	Landing Width (in)	N/A	N/A	DWS Contrast?	N/A
N/A	Landing Slope (%)	N/A	N/A	DWS Length (in)	N/A
N/A	Landing X Slope (%)	N/A	N/A	DWS Full Width?	N/A
N/A	Landing Curb? (Y/N)	N/A	N/A	DWS Offset (in)	N/A
N/A	Shared Landing?	N/A			
N/A	Gutter Ponding?	N/A	N/A	Gutter Slope (%)	N/A
N/A	Gutter Lip Ht (in)	N/A	N/A	Gutter X Slope (%)	N/A
N/A	Painted X Walk1?	No	N/A	Painted X Walk2?	No
	X Walk 1 Direction	To NE		X Walk 2 Direction	To NW
N/A	X Walk 1 Width (in)	N/A	N/A	X Walk 2 Width (in)	N/A
	X Walk 1 Slope (%)	5.1		X Walk 2 Slope (%)	8.7
	X Walk 1 X Slope (%)	8.3		X Walk 2 X Slope (%)	3.2

N/A	Ramp inside XWalk1?	N/A	N/A	Ramp inside XWalk2?	N/A
	Road Slope (%)	4.9	N/A	Clear Space?	N/A
	Road X Slope (%)	6.0	N/A	Clear Space to XWalk (in)	N/A
N/A	Any Obstructions?	N/A	N/A	Storm Grate/Utility Hazard?	N/A
	Obstruction Type			Storm Grate/Utility Type	
		N/A			N/A
			Yes	Surface Condition? (G/P)	Good

**Remove & Replace Curb Ramp With Two New Directional Ramps or Equivalent.**
