# Access Compliance Report

## Public Rights-of-Way

### (Curb Ramps)

Intersection ID: 20422	Main Street: W_ARROWOOD_RD	Cross Street: S_TRYON_ST	Location: NW
ADA ID: B7F74D8D91D8	Ramp Type: Perp	Initial Pass/Fail: Fail	Overall Compliance: No
			Severity Score: 13.75

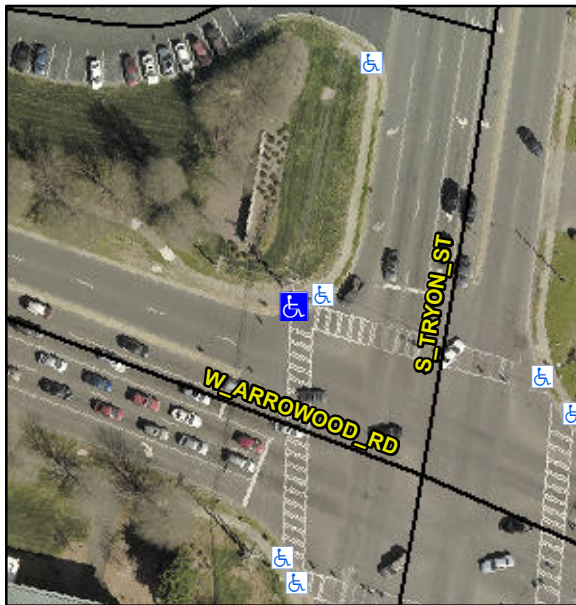
**Not Found, R304.2.2**

Compliance	Description	Data	Compliance	Description	Data
N/A	Ramp Length (in)	76.0	No	Ramp Slope (%)	10.2
Yes	Ramp Width (in)	48.0	Yes	Ramp XSlope (%)	2.4
N/A	Flare Type LT	N/A	N/A	Flare Type RT	N/A
N/A	Flare Slope LT (%)	N/A	N/A	Flare Slope RT (%)	N/A
N/A	Flare Traversable LT?	N/A	N/A	Flare Traversable RT?	N/A
N/A	Landing Length (in)	N/A	N/A	DWS Provided?	N/A
N/A	Landing Width (in)	N/A	N/A	DWS Contrast?	N/A
N/A	Landing Slope (%)	N/A	N/A	DWS Length (in)	N/A
N/A	Landing X Slope (%)	N/A	N/A	DWS Full Width?	N/A
N/A	Landing Curb? (Y/N)	N/A	N/A	DWS Offset (in)	N/A
N/A	Shared Landing?	N/A			
N/A	Gutter Ponding?	N/A	N/A	Gutter Slope (%)	N/A
N/A	Gutter Lip Ht (in)	N/A	N/A	Gutter X Slope (%)	N/A
N/A	Painted X Walk1?	Yes	N/A	Painted X Walk2?	N/A
	X Walk 1 Direction	To S		X Walk 2 Direction	N/A
N/A	X Walk 1 Width (in)	131.0	N/A	X Walk 2 Width (in)	N/A
	X Walk 1 Slope (%)	1.9		X Walk 2 Slope (%)	N/A
	X Walk 1 X Slope (%)	2.4		X Walk 2 X Slope (%)	N/A

N/A	Ramp inside XWalk1?	No	N/A	Ramp inside XWalk2?	N/A
	Road Slope (%)	N/A	N/A	Clear Space?	N/A
	Road X Slope (%)	N/A	N/A	Clear Space to XWalk (in)	N/A
N/A	Any Obstructions?	N/A	N/A	Storm Grate/Utility Hazard?	N/A
	Obstruction Type			Storm Grate/Utility Type	
		N/A			N/A
			Yes	Surface Condition? (G/P)	Good

**Remove & Replace Entire Ramp.  
Restripe Crosswalk.**
