# Access Compliance Report

## Public Rights-of-Way

Intersection ID: 11260	Main Street: BROOK_RD	Cross Street: CLEMSON_AV	Location: S
ADA ID: B819B91A197F	Ramp Type: PerpDiag	Initial Pass/Fail: Fail	Overall Compliance: No
Codes/Mitigation Info/Possible Solution		Field Measurements/Component Compliance

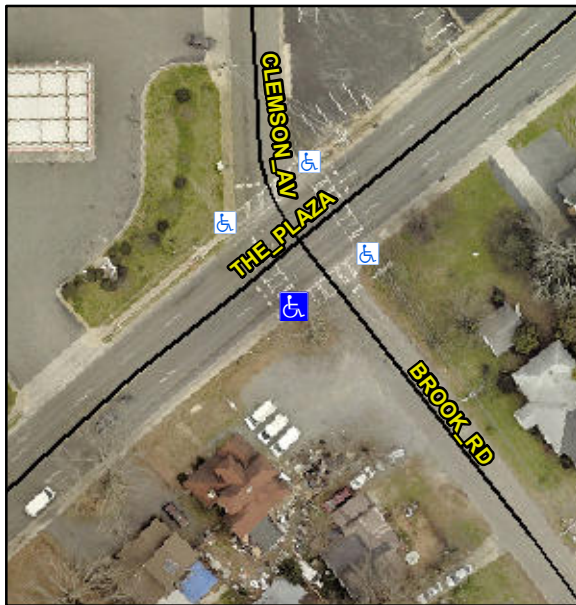
**Not Found, R304.5.1, R304.2.2, R304.5.3**

Compliance	Description	Data	Compliance	Description	Data
N/A	Ramp Length (in)	58.5	No	Ramp Slope (%)	9.2
No	Ramp Width (in)	40.0	No	Ramp XSlope (%)	5.7
N/A	Flare Type LT	N/A	N/A	Flare Type RT	N/A
N/A	Flare Slope LT (%)	N/A	N/A	Flare Slope RT (%)	N/A
N/A	Flare Traversable LT?	N/A	N/A	Flare Traversable RT?	N/A
N/A	Landing Length (in)	N/A	N/A	DWS Provided?	N/A
N/A	Landing Width (in)	N/A	N/A	DWS Contrast?	N/A
N/A	Landing Slope (%)	N/A	N/A	DWS Length (in)	N/A
N/A	Landing X Slope (%)	N/A	N/A	DWS Full Width?	N/A
N/A	Landing Curb? (Y/N)	N/A	N/A	DWS Offset (in)	N/A
N/A	Shared Landing?	N/A			
N/A	Gutter Ponding?	N/A	N/A	Gutter Slope (%)	N/A
N/A	Gutter Lip Ht (in)	N/A	N/A	Gutter X Slope (%)	N/A
N/A	Painted X Walk1?	Yes	N/A	Painted X Walk2?	Yes
	X Walk 1 Direction	To NE		X Walk 2 Direction	To NW
N/A	X Walk 1 Width (in)	107.0	N/A	X Walk 2 Width (in)	109.0
	X Walk 1 Slope (%)	1.0		X Walk 2 Slope (%)	1.8
	X Walk 1 X Slope (%)	2.3		X Walk 2 X Slope (%)	0.3

N/A	Ramp inside XWalk1?	Yes	N/A	Ramp inside XWalk2?	Yes
	Road Slope (%)	7.8	N/A	Clear Space?	N/A
	Road X Slope (%)	3.4	N/A	Clear Space to XWalk (in)	N/A
N/A	Any Obstructions?	N/A	N/A	Storm Grate/Utility Hazard?	N/A
	Obstruction Type			Storm Grate/Utility Type	
		N/A			N/A
			Yes	Surface Condition? (G/P)	Good

**Remove & Replace Curb Ramp With Two New Directional Ramps or Equivalent.**
