Access Compliance Report

Public Rights-of-Way

(Curb Ramps)

Intersection ID: 53922	Main Street: ERICA_WOODS_LN	Cross Street: PINYON_PINE_LN	Location: W
ADA ID: B82494CB6067	Ramp Type: Perp	Initial Pass/Fail: Fail	Overall Compliance: No
		Severity Score: 10

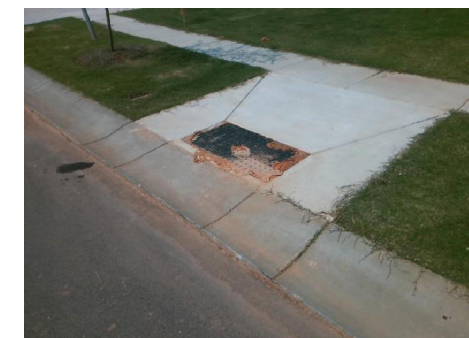
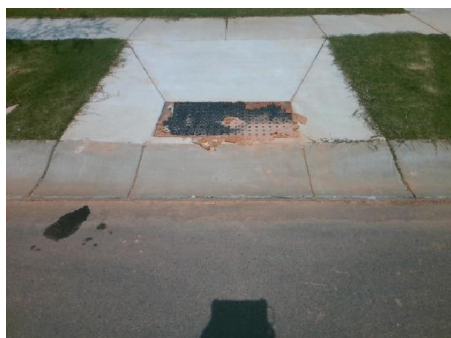
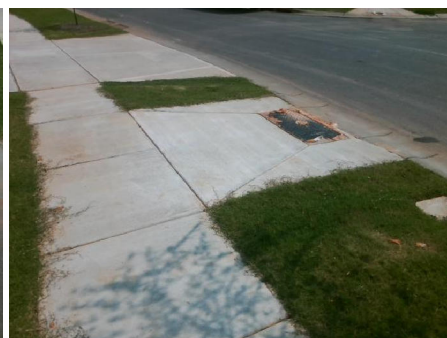
Not Found, R304.5.1, R304.5.3

Compliance	Description	Data	Compliance	Description	Data
N/A	Ramp Length (in)	91.5	Yes	Ramp Slope (%)	5.1
No	Ramp Width (in)	47.5	No	Ramp XSlope (%)	2.5
N/A	Flare Type LT	N/A	N/A	Flare Type RT	N/A
N/A	Flare Slope LT (%)	N/A	N/A	Flare Slope RT (%)	N/A
N/A	Flare Traversable LT?	N/A	N/A	Flare Traversable RT?	N/A
N/A	Landing Length (in)	N/A	N/A	DWS Provided?	N/A
N/A	Landing Width (in)	N/A	N/A	DWS Contrast?	N/A
N/A	Landing Slope (%)	N/A	N/A	DWS Length (in)	N/A
N/A	Landing X Slope (%)	N/A	N/A	DWS Full Width?	N/A
N/A	Landing Curb? (Y/N)	N/A	N/A	DWS Offset (in)	N/A
N/A	Shared Landing?	N/A			
N/A	Gutter Ponding?	N/A	N/A	Gutter Slope (%)	N/A
N/A	Gutter Lip Ht (in)	N/A	N/A	Gutter X Slope (%)	N/A
N/A	Painted X Walk1?	No	N/A	Painted X Walk2?	N/A
	X Walk 1 Direction	To S		X Walk 2 Direction	N/A
N/A	X Walk 1 Width (in)	N/A	N/A	X Walk 2 Width (in)	N/A
	X Walk 1 Slope (%)	5.5		X Walk 2 Slope (%)	N/A
	X Walk 1 X Slope (%)	1.6		X Walk 2 X Slope (%)	N/A

N/A	Ramp inside XWalk1?	N/A	N/A	Ramp inside XWalk2?	N/A
	Road Slope (%)	N/A	N/A	Clear Space?	N/A
	Road X Slope (%)	N/A	N/A	Clear Space to XWalk (in)	N/A
N/A	Any Obstructions?	N/A	N/A	Storm Grate/Utility Hazard?	N/A
	Obstruction Type			Storm Grate/Utility Type	
		N/A			N/A
			Yes	Surface Condition? (G/P)	Good

Remove & Replace Entire Ramp.
