Access Compliance Report

Public Rights-of-Way

(Curb Ramps)

Intersection ID: 7888	Main Street: STATESVILLE_AV	Cross Street: HICKORY_LN	Location: SE
ADA ID: B8268EEE89F4	Ramp Type: Combination1	Initial Pass/Fail: Fail	Overall Compliance: No
Codes/Mitigation Info/Possible Solution		Field Measurements/Component Compliance	
Severity Score: 46.25

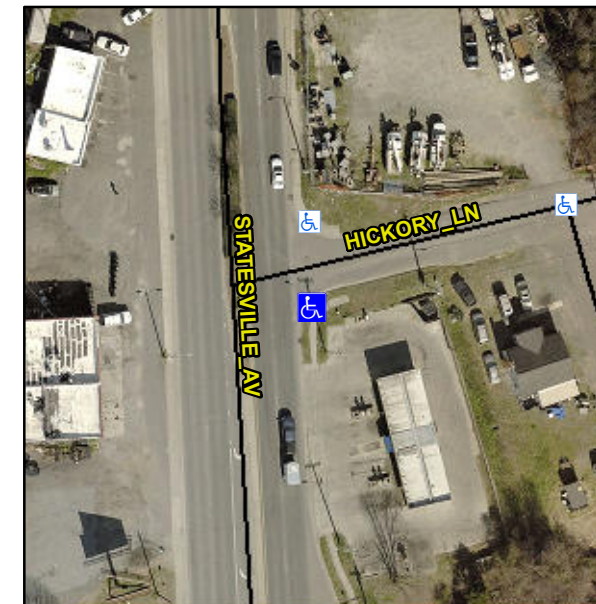
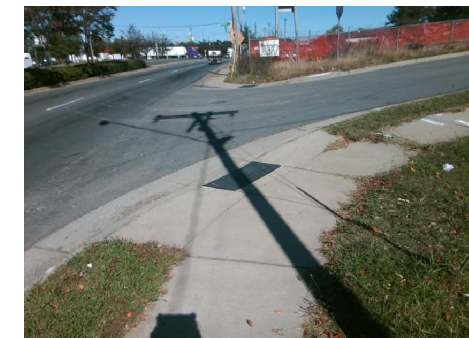
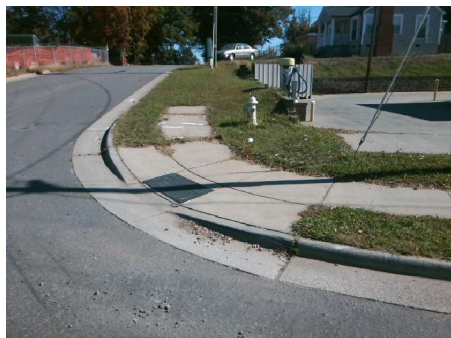
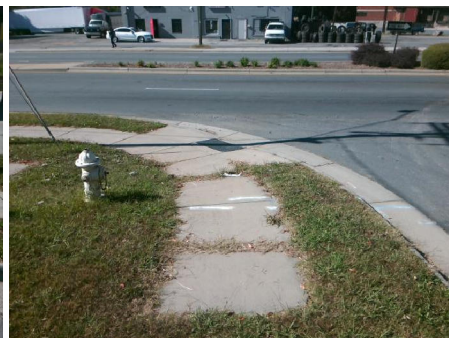
RT RP < 5%

R304.5.1, R304.5.3, R304.3.2

Compliance	Description	Data	Compliance	Description	Data
N/A	Ramp Length LT (in)	48.0	N/A	Ramp Length RT (in)	43.0
Yes	Ramp Width LT (in)	60.0	Yes	Ramp Width RT (in)	60.0
No	Ramp Slope LT (%)	17.0	Yes	Ramp Slope RT (%)	2.8
No	Ramp XSlope LT (%)	3.5	No	Ramp XSlope RT (%)	2.8
N/A	Ramp Length (in)	36.0	Yes	Ramp Slope (%)	7.1
No	Ramp Width (in)	42.5	No	Ramp XSlope (%)	5.8
N/A	Flare Type LT	N/A	N/A	Flare Type RT	N/A
N/A	Flare Slope LT (%)	N/A	N/A	Flare Slope RT (%)	N/A
N/A	Flare Traversable LT?	N/A	N/A	Flare Traversable RT?	N/A
N/A	Landing Length (in)	N/A	N/A	DWS Provided?	N/A
N/A	Landing Width (in)	N/A	N/A	DWS Contrast?	N/A
N/A	Landing Slope (%)	N/A	N/A	DWS Length (in)	N/A
N/A	Landing X Slope (%)	N/A	N/A	DWS Full Width?	N/A
N/A	Landing Curb? (Y/N)	N/A	N/A	DWS Offset (in)	N/A
N/A	Shared Landing?	N/A			
N/A	Gutter Ponding?	N/A	N/A	Gutter Slope (%)	N/A
N/A	Gutter Lip Ht (in)	N/A	N/A	Gutter X Slope (%)	N/A
N/A	Painted X Walk1?	No	N/A	Painted X Walk2?	N/A

X Walk 1 Direction	To N		X Walk 2 Direction	N/A
	X Walk 1 Width (in)	N/A		X Walk 2 Width (in)	N/A
	X Walk 1 Slope (%)	5.4		X Walk 2 Slope (%)	N/A
	X Walk 1 X Slope (%)	6.5		X Walk 2 X Slope (%)	N/A
N/A	Ramp inside XWalk1?	N/A	N/A	Ramp inside XWalk2?	N/A
	Road Slope (%)	N/A		Clear Space?	N/A
	Road X Slope (%)	N/A	N/A	Clear Space to XWalk (in)	N/A
			N/A	Any Obstruction?	N/A
				Obstruction Type	N/A
			N/A	Storm Grate/Utility Hazard?	N/A
				Storm Grate/Utility Type	N/A
Yes	Surface Condition? (G/P)	Good			
	Curb Slope (%)	2.8

Possible Solutions:

Remove & Replace Entire Ramp.
