Intersection ID: 17409	Main Street: HILLSIDE_AV	Cross Street: PARK_RD	Location:	SE
ADA ID: B835036D1AA0	Ramp Type: Perp	Initial Pass/Fail: Fail	Overall Compliance: No	Severity Score: 36.25

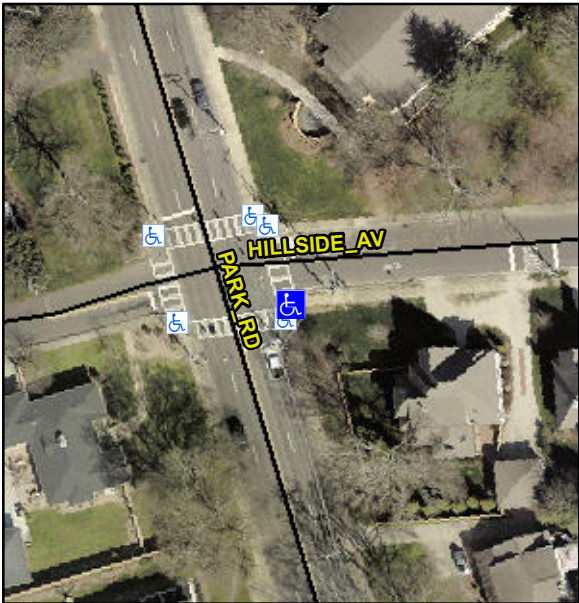
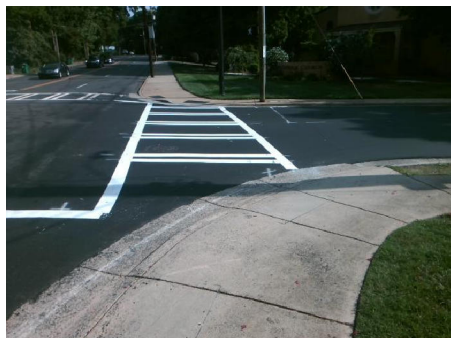
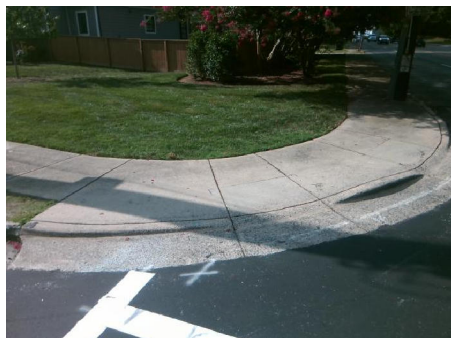
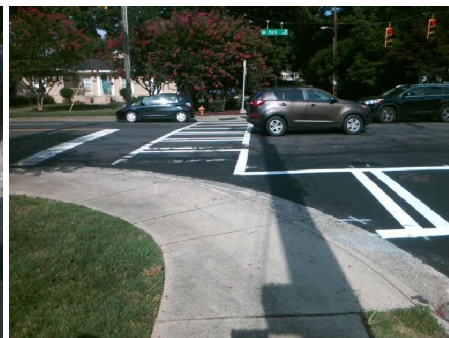
Possible Solutions:		<b>Compliance</b>	<b>Description</b>	<b>Data</b>	<b>Compliance</b>	<b>Description</b>	<b>Data</b>
	<b>Remove &amp; Replace Entire Ramp.</b>		<b>N/A</b>	Ramp Length (in)	<b>70.0</b>	<b>Yes</b>	Ramp Slope (%)	<b>5.5</b>
			<b>No</b>	Ramp Width (in)	<b>30.0</b>	<b>No</b>	Ramp XSlope (%)	<b>4.8</b>
			<b>N/A</b>	Flare Type LT	<b>N/A</b>	<b>N/A</b>	Flare Type RT	<b>N/A</b>
			<b>N/A</b>	Flare Slope LT (%)	<b>N/A</b>	<b>N/A</b>	Flare Slope RT (%)	<b>N/A</b>
			<b>N/A</b>	Flare Traversable LT?	<b>N/A</b>	<b>N/A</b>	Flare Traversable RT?	<b>N/A</b>
			<b>N/A</b>	Landing Length (in)	<b>N/A</b>	<b>N/A</b>	DWS Provided?	<b>N/A</b>
			<b>N/A</b>	Landing Width (in)	<b>N/A</b>	<b>N/A</b>	DWS Contrast?	<b>N/A</b>
			<b>N/A</b>	Landing Slope (%)	<b>N/A</b>	<b>N/A</b>	DWS Length (in)	<b>N/A</b>
			<b>N/A</b>	Landing X Slope (%)	<b>N/A</b>	<b>N/A</b>	DWS Full Width?	<b>N/A</b>

Surveyor Notes:		<b>N/A</b>	<b>N/A</b>	Landing Curb? (Y/N)	<b>N/A</b>	<b>N/A</b>	DWS Offset (in)	<b>N/A</b>
PROW/ADA:		<b>Not Found, R304.5.1, R304.5.3</b>	<b>N/A</b>	Shared Landing?	<b>N/A</b>			
			<b>N/A</b>	Gutter Ponding?	<b>N/A</b>	<b>N/A</b>	Gutter Slope (%)	<b>N/A</b>
			<b>N/A</b>	Gutter Lip Ht (in)	<b>N/A</b>	<b>N/A</b>	Gutter X Slope (%)	<b>N/A</b>
			<b>N/A</b>	Painted X Walk1?	<b>Yes</b>	<b>N/A</b>	Painted X Walk2?	<b>N/A</b>
				X Walk 1 Direction	<b>To N</b>		X Walk 2 Direction	<b>N/A</b>
			<b>N/A</b>	X Walk 1 Width (in)	<b>112.0</b>	<b>N/A</b>	X Walk 2 Width (in)	<b>N/A</b>
				X Walk 1 Slope (%)	<b>2.6</b>		X Walk 2 Slope (%)	<b>N/A</b>
				X Walk 1 X Slope (%)	<b>4.7</b>		X Walk 2 X Slope (%)	<b>N/A</b>
Street 1 Name		<b>HILLSIDE AV</b>	<b>N/A</b>	Ramp inside XWalk1?	<b>Yes</b>	<b>N/A</b>	Ramp inside XWalk2?	<b>N/A</b>
Stop Condition-Street 2		<b>Signal</b>		Road Slope (%)	<b>N/A</b>	<b>N/A</b>	Clear Space?	<b>N/A</b>
