Access Compliance Report

Public Rights-of-Way

(Curb Ramps)

Intersection ID: N/A	Main Street: SPRATT_ST	Cross Street: N/A	Location: NW
ADA ID: B83F2572B49C	Ramp Type: Perp	Initial Pass/Fail: Fail	Overall Compliance: No
Severity Score: 12.5			
Codes/Mitigation Info/Possible Solution		Field Measurements/Component Compliance

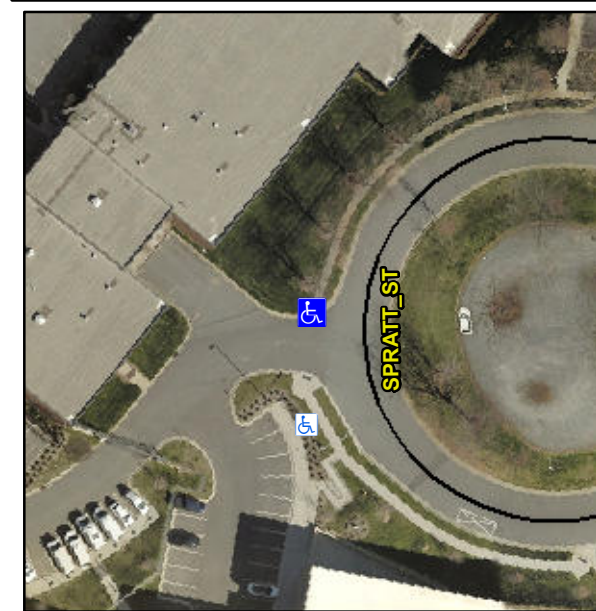
Not Found, R304.2.2

Compliance	Description	Data	Compliance	Description	Data
N/A	Ramp Length (in)	43.0	No	Ramp Slope (%)	9.8
Yes	Ramp Width (in)	48.0	Yes	Ramp XSlope (%)	1.2
N/A	Flare Type LT	N/A	N/A	Flare Type RT	N/A
N/A	Flare Slope LT (%)	N/A	N/A	Flare Slope RT (%)	N/A
N/A	Flare Traversable LT?	N/A	N/A	Flare Traversable RT?	N/A
N/A	Landing Length (in)	N/A	N/A	DWS Provided?	N/A
N/A	Landing Width (in)	N/A	N/A	DWS Contrast?	N/A
N/A	Landing Slope (%)	N/A	N/A	DWS Length (in)	N/A
N/A	Landing X Slope (%)	N/A	N/A	DWS Full Width?	N/A
N/A	Landing Curb? (Y/N)	N/A	N/A	DWS Offset (in)	N/A
N/A	Shared Landing?	N/A			
N/A	Gutter Ponding?	N/A	N/A	Gutter Slope (%)	N/A
N/A	Gutter Lip Ht (in)	N/A	N/A	Gutter X Slope (%)	N/A
N/A	Painted X Walk1?	No	N/A	Painted X Walk2?	N/A
	X Walk 1 Direction	To S		X Walk 2 Direction	N/A
N/A	X Walk 1 Width (in)	N/A	N/A	X Walk 2 Width (in)	N/A
	X Walk 1 Slope (%)	2.1		X Walk 2 Slope (%)	N/A
	X Walk 1 X Slope (%)	5.8		X Walk 2 X Slope (%)	N/A

N/A	Ramp inside XWalk1?	N/A	N/A	Ramp inside XWalk2?	N/A
	Road Slope (%)	N/A	N/A	Clear Space?	N/A
	Road X Slope (%)	N/A	N/A	Clear Space to XWalk (in)	N/A
N/A	Any Obstructions?	N/A	N/A	Storm Grate/Utility Hazard?	N/A
	Obstruction Type			Storm Grate/Utility Type	
		N/A			N/A
			Yes	Surface Condition? (G/P)	Good

Possible Solutions:

Remove & Replace Entire Ramp.
