Access Compliance Report

Public Rights-of-Way

(Curb Ramps)

Intersection ID: 28446	Main Street: SHINING_OAK_LN	Cross Street: SUMMER_CREEK_LN	Location: NE
ADA ID: B842C0A8EF4B	Ramp Type: Para	Initial Pass/Fail: Fail	Overall Compliance: No
Severity Score: 12.5			
Codes/Mitigation Info/Possible Solution		Field Measurements/Component Compliance

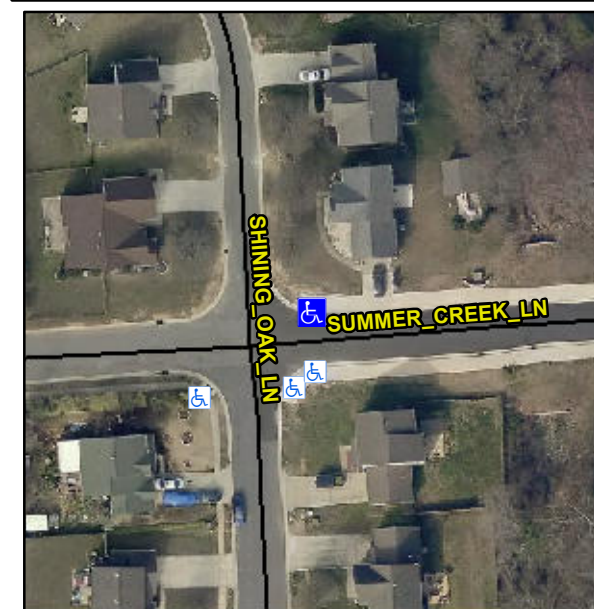
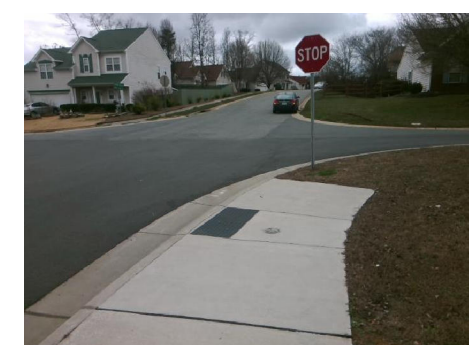
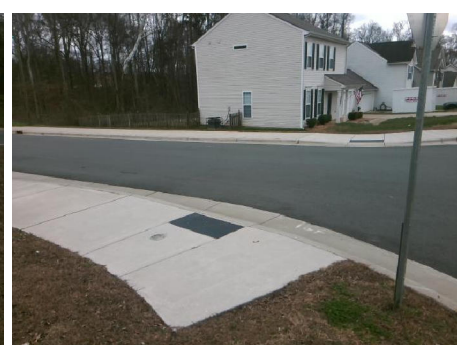
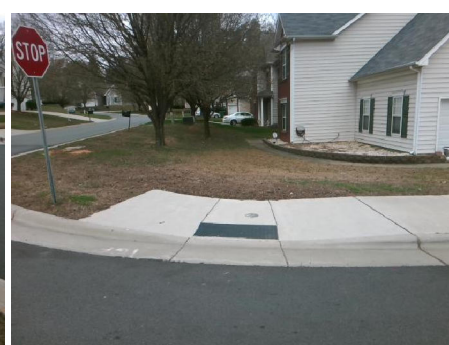
RT RP < 5%

Compliance	Description	Data	Compliance	Description	Data
N/A	Ramp Length LT (in)	58.0	N/A	Ramp Length RT (in)	67.0
Yes	Ramp Width LT (in)	84.0	Yes	Ramp Width RT (in)	84.0
No	Ramp Slope LT (%)	10.7	Yes	Ramp Slope RT (%)	1.1
Yes	Ramp XSlope LT (%)	1.2	Yes	Ramp XSlope RT (%)	1.0
N/A	Landing Length (in)	N/A	N/A	DWS Provided?	N/A
N/A	Landing Width (in)	N/A	N/A	DWS Contrast?	N/A
N/A	Landing Slope (%)	N/A	N/A	DWS Length (in)	N/A
N/A	Landing X Slope (%)	N/A	N/A	DWS Full Width?	N/A
N/A	Landing Curb? (Y/N)	N/A	N/A	DWS Offset (in)	N/A
N/A	Shared Landing?	N/A			
N/A	Gutter Ponding?	N/A	N/A	Gutter Slope (%)	N/A
N/A	Gutter Lip Ht (in)	N/A	N/A	Gutter X Slope (%)	N/A
N/A	Painted X Walk1?	No	N/A	Painted X Walk2?	N/A
	X Walk 1 Direction	To S		X Walk 2 Direction	N/A
N/A	X Walk 1 Width (in)	N/A	N/A	X Walk 2 Width (in)	N/A
	X Walk 1 Slope (%)	0.7		X Walk 2 Slope (%)	N/A
	X Walk 1 X Slope (%)	3.6		X Walk 2 X Slope (%)	N/A
N/A	Ramp inside XWalk1?	N/A	N/A	Ramp inside XWalk2?	N/A

Road Slope (%)	N/A	N/A	Clear Space?	N/A
	Road X Slope (%)	N/A	N/A	Clear Space to XWalk (in)	N/A
N/A	Any Obstructions?	N/A	N/A	Storm Grate/Utility Hazard?	N/A
	Obstruction Type			Storm Grate/Utility Type	
		N/A			N/A
			Yes	Surface Condition? (G/P)	Good
			N/A	Curb Slope (%)	15.4

Remove & Replace Entire Ramp.

R304.3.2
