Access Compliance Report

Public Rights-of-Way

(Curb Ramps)

Intersection ID: 47576	Main Street: BARRANDS_LN	Cross Street: SEDGEBURN_DR	Location: NE
ADA ID: B842FF72CBC4	Ramp Type: Perp	Initial Pass/Fail: Fail	Overall Compliance: No
Severity Score: 12.5			
Codes/Mitigation Info/Possible Solution		Field Measurements/Component Compliance

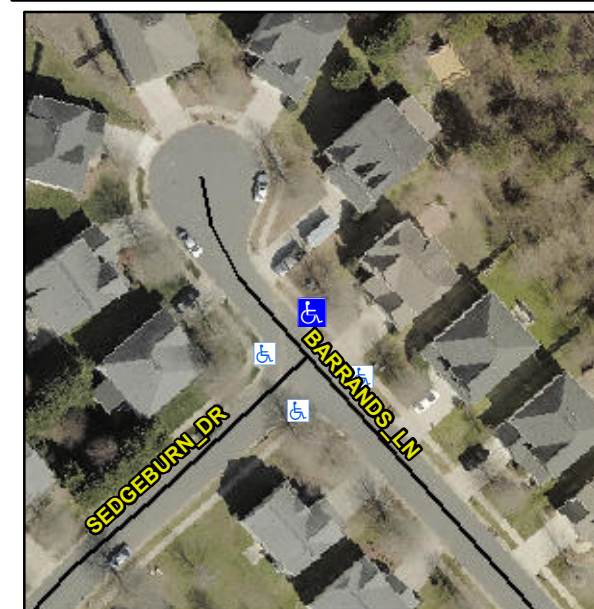
PROW/ADA:

Not Found, R304.2.2

Compliance	Description	Data	Compliance	Description	Data
N/A	Ramp Length (in)	48.0	No	Ramp Slope (%)	8.8
Yes	Ramp Width (in)	48.0	Yes	Ramp XSlope (%)	0.2
N/A	Flare Type LT	N/A	N/A	Flare Type RT	N/A
N/A	Flare Slope LT (%)	N/A	N/A	Flare Slope RT (%)	N/A
N/A	Flare Traversable LT?	N/A	N/A	Flare Traversable RT?	N/A
N/A	Landing Length (in)	N/A	N/A	DWS Provided?	N/A
N/A	Landing Width (in)	N/A	N/A	DWS Contrast?	N/A
N/A	Landing Slope (%)	N/A	N/A	DWS Length (in)	N/A
N/A	Landing X Slope (%)	N/A	N/A	DWS Full Width?	N/A
N/A	Landing Curb? (Y/N)	N/A	N/A	DWS Offset (in)	N/A
N/A	Shared Landing?	N/A			
N/A	Gutter Ponding?	N/A	N/A	Gutter Slope (%)	N/A
N/A	Gutter Lip Ht (in)	N/A	N/A	Gutter X Slope (%)	N/A
N/A	Painted X Walk1?	No	N/A	Painted X Walk2?	N/A
	X Walk 1 Direction	To SW		X Walk 2 Direction	N/A
N/A	X Walk 1 Width (in)	N/A	N/A	X Walk 2 Width (in)	N/A
	X Walk 1 Slope (%)	1.9		X Walk 2 Slope (%)	N/A
	X Walk 1 X Slope (%)	1.4		X Walk 2 X Slope (%)	N/A

Possible Solutions:

Remove & Replace Entire Ramp.
