Access Compliance Report

Public Rights-of-Way

(Curb Ramps)

Intersection ID: 7753	Main Street: BILMARK_AV	Cross Street: HUGHES_DR	Location: SE
ADA ID: B84943143AED	Ramp Type: BlendTrans1	Initial Pass/Fail: Fail	Overall Compliance: No
Codes/Mitigation Info/Possible Solution		Field Measurements/Component Compliance	
Severity Score: 8.75

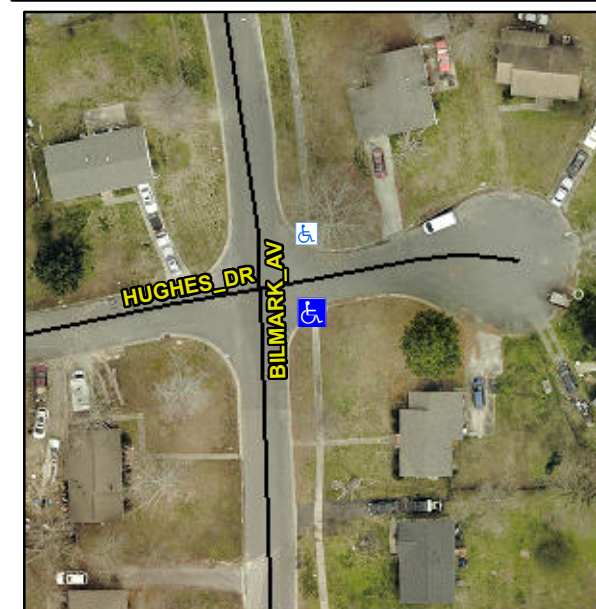
Not Found, R304.5.1

Remove & Replace Curb Ramp With Two New Directional Ramps or Equivalent.

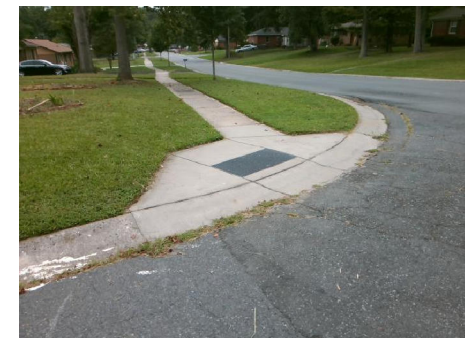
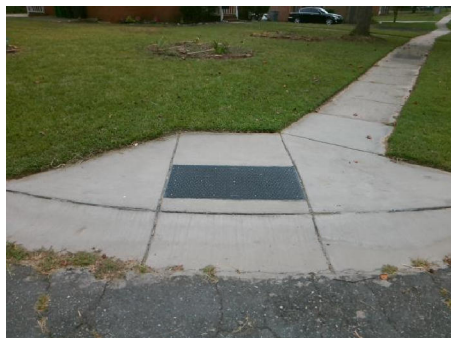
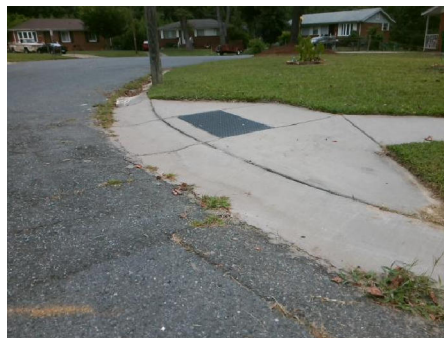
Compliance	Description	Data	Compliance	Description	Data
N/A	Ramp Length (in)	31.0	Yes	BlendTrans Slope (%)	3.5
No	Ramp Width (in)	47.0	Yes	BlendTrans XSlope (%)	1.1
N/A	Flare Type LT	N/A	N/A	Flare Type RT	N/A
N/A	Flare Slope LT (%)	N/A	N/A	Flare Slope RT (%)	N/A
N/A	Flare Traversable LT?	N/A	N/A	Flare Traversable RT?	N/A
N/A	Landing Length (in)	N/A	N/A	DWS Provided?	N/A
N/A	Landing Width (in)	N/A	N/A	DWS Contrast?	N/A
N/A	Landing Slope (%)	N/A	N/A	DWS Length (in)	N/A
N/A	Landing X Slope (%)	N/A	N/A	DWS Full Width?	N/A
N/A	Landing Curb? (Y/N)	N/A	N/A	DWS Offset (in)	N/A
N/A	Shared Landing?	N/A			
N/A	Gutter Ponding?	N/A	N/A	Gutter Slope (%)	N/A
N/A	Gutter Lip Ht (in)	N/A	N/A	Gutter X Slope (%)	N/A
N/A	Painted X Walk1?	No	N/A	Painted X Walk2?	N/A
	X Walk 1 Direction	To N		X Walk 2 Direction	N/A
	X Walk 1 Width (in)	N/A		X Walk 2 Width (in)	N/A
	X Walk 1 Slope (%)	3.1		X Walk 2 Slope (%)	N/A
	X Walk 1 X Slope (%)	3.4		X Walk 2 X Slope (%)	N/A

N/A	Ramp inside XWalk1?	N/A	N/A	Ramp inside XWalk2?	N/A
	Road Slope (%)	3.4		Clear Space?	N/A
	Road X Slope (%)	3.1	N/A	Clear Space to XWalk (in)	N/A
N/A	Any Obstructions?	N/A	N/A	Storm Grate/Utility Hazard?	N/A
	Obstruction Type			Storm Grate/Utility Type	
		N/A			N/A
			Yes	Surface Condition? (G/P)	Good
			No	Curb Slope (%)	18.3
