Access Compliance Report

Public Rights-of-Way

(Curb Ramps)

Intersection ID: 54320	Main Street: WRIGLEY_MANSION_DR	Cross Street: CANTERBURY_CASTLE_DR	Location: SW
ADA ID: B8550E884EBC	Ramp Type: Perp	Initial Pass/Fail: Fail	Overall Compliance: No
Severity Score: 12.5			
Codes/Mitigation Info/Possible Solution		Field Measurements/Component Compliance

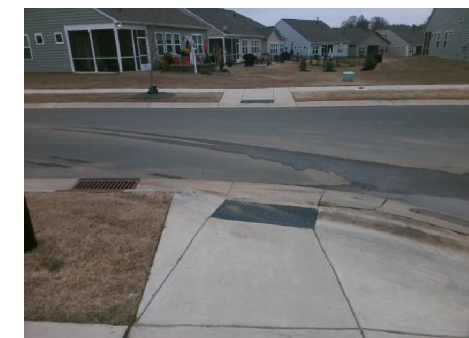
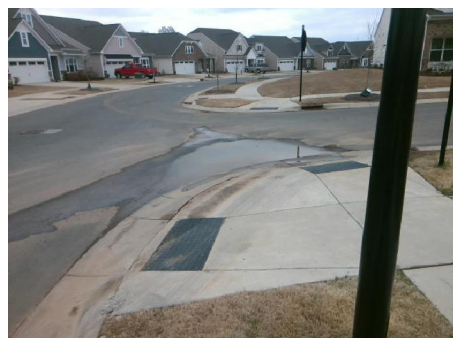
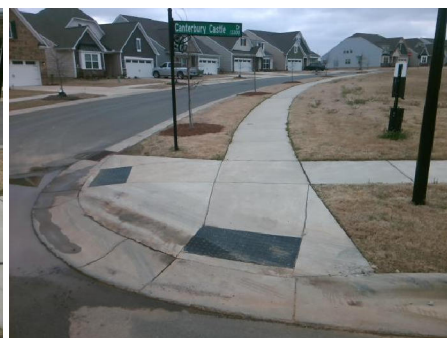
Not Found, R304.5.3

Compliance	Description	Data	Compliance	Description	Data
N/A	Ramp Length (in)	88.0	Yes	Ramp Slope (%)	6.0
Yes	Ramp Width (in)	48.0	No	Ramp XSlope (%)	6.4
N/A	Flare Type LT	N/A	N/A	Flare Type RT	N/A
N/A	Flare Slope LT (%)	N/A	N/A	Flare Slope RT (%)	N/A
N/A	Flare Traversable LT?	N/A	N/A	Flare Traversable RT?	N/A
N/A	Landing Length (in)	N/A	N/A	DWS Provided?	N/A
N/A	Landing Width (in)	N/A	N/A	DWS Contrast?	N/A
N/A	Landing Slope (%)	N/A	N/A	DWS Length (in)	N/A
N/A	Landing X Slope (%)	N/A	N/A	DWS Full Width?	N/A
N/A	Landing Curb? (Y/N)	N/A	N/A	DWS Offset (in)	N/A
N/A	Shared Landing?	N/A			
N/A	Gutter Ponding?	N/A	N/A	Gutter Slope (%)	N/A
N/A	Gutter Lip Ht (in)	1.0	N/A	Gutter X Slope (%)	N/A
N/A	Painted X Walk1?	No	N/A	Painted X Walk2?	N/A
	X Walk 1 Direction	To N		X Walk 2 Direction	N/A
N/A	X Walk 1 Width (in)	N/A	N/A	X Walk 2 Width (in)	N/A
	X Walk 1 Slope (%)	3.0		X Walk 2 Slope (%)	N/A
	X Walk 1 X Slope (%)	1.5		X Walk 2 X Slope (%)	N/A

N/A	Ramp inside XWalk1?	N/A	N/A	Ramp inside XWalk2?	N/A
	Road Slope (%)	N/A	N/A	Clear Space?	N/A
	Road X Slope (%)	N/A	N/A	Clear Space to XWalk (in)	N/A
N/A	Any Obstructions?	N/A	N/A	Storm Grate/Utility Hazard?	N/A
	Obstruction Type			Storm Grate/Utility Type	
		N/A			N/A
		Yes		Surface Condition? (G/P)	Good

Possible Solutions:

Remove & Replace Entire Ramp.
