Intersection ID: 50327	Main Street: HENRY_DAVID_CT	Cross Street: SHARPES_CR	Location:	SW
ADA ID: B86074CE0544	Ramp Type: PerpDiag	Initial Pass/Fail: Fail	Overall Compliance: No	Severity Score: 46.25

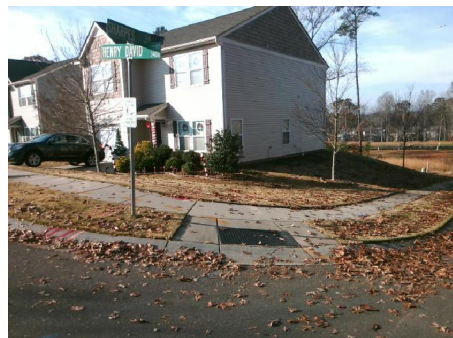
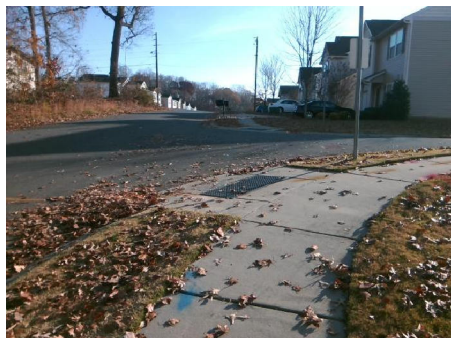
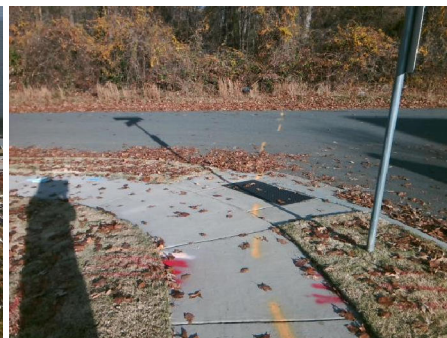
**Not Found, R304.5.1, R304.2.2,
R304.5.3**

Compliance	Description	Data	Compliance	Description	Data
N/A	Ramp Length (in)	48.0	No	Ramp Slope (%)	9.4
No	Ramp Width (in)	41.0	No	Ramp XSlope (%)	12.3
N/A	Flare Type LT	N/A	N/A	Flare Type RT	N/A
N/A	Flare Slope LT (%)	N/A	N/A	Flare Slope RT (%)	N/A
N/A	Flare Traversable LT?	N/A	N/A	Flare Traversable RT?	N/A
N/A	Landing Length (in)	N/A	N/A	DWS Provided?	N/A
N/A	Landing Width (in)	N/A	N/A	DWS Contrast?	N/A
N/A	Landing Slope (%)	N/A	N/A	DWS Length (in)	N/A
N/A	Landing X Slope (%)	N/A	N/A	DWS Full Width?	N/A
N/A	Landing Curb? (Y/N)	N/A	N/A	DWS Offset (in)	N/A
N/A	Shared Landing?	N/A			
N/A	Gutter Ponding?	N/A	N/A	Gutter Slope (%)	N/A
N/A	Gutter Lip Ht (in)	0.5	N/A	Gutter X Slope (%)	N/A
N/A	Painted X Walk1?	No	N/A	Painted X Walk2?	No
	X Walk 1 Direction	To E		X Walk 2 Direction	To N
N/A	X Walk 1 Width (in)	N/A	N/A	X Walk 2 Width (in)	N/A
	X Walk 1 Slope (%)	12.4		X Walk 2 Slope (%)	2.3
	X Walk 1 X Slope (%)	2.0		X Walk 2 X Slope (%)	11.0

N/A	Ramp inside XWalk1?	N/A	N/A	Ramp inside XWalk2?	N/A
	Road Slope (%)	8.9	N/A	Clear Space?	N/A
	Road X Slope (%)	4.4	N/A	Clear Space to XWalk (in)	N/A
N/A	Any Obstructions?	N/A	N/A	Storm Grate/Utility Hazard?	N/A
	Obstruction Type			Storm Grate/Utility Type	
		N/A			N/A
			Yes	Surface Condition? (G/P)	Good

Remove & Replace Curb Ramp With Two New Directional Ramps or Equivalent.
