# Access Compliance Report

## Public Rights-of-Way

### (Curb Ramps)

| Intersection ID: 10038340 | Main Street: SOUTH_BV | Cross Street: N/A | Location: NW |

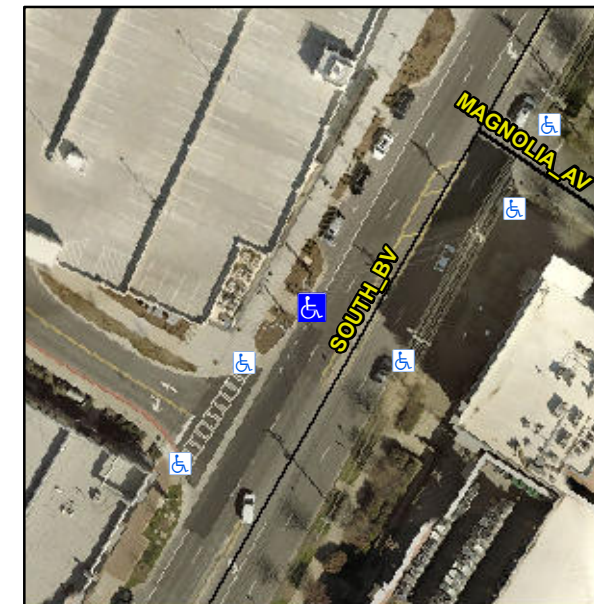
| ADA ID: B86920CEE0D7 | Ramp Type: Perp | Initial Pass/Fail: Fail | Overall Compliance: No |
| | | Severity Score: 12.5 | |

**Not Found, R304.2.2**

| Compliance | Description | Data | Compliance | Description | Data |
|---|---|---|---|---|---|
| N/A | Ramp Length (in) | 65.0 | No | Ramp Slope (%) | 9.6 |

**Remove & Replace Entire Ramp.**

Total Cost: \$ 1850.00
