Access Compliance Report

Public Rights-of-Way

(Curb Ramps)

Intersection ID: 23481	Main Street: ALEXANDER_RD	Cross Street: PROVIDENCE_RD	Location: NW
ADA ID: B86AEF638869	Ramp Type: Perp	Initial Pass/Fail: Fail	Overall Compliance: No
Severity Score: 22.5			
Codes/Mitigation Info/Possible Solution		Field Measurements/Component Compliance

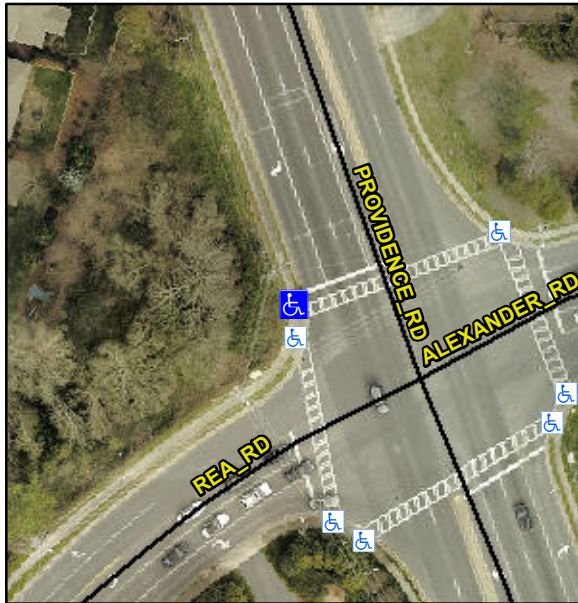
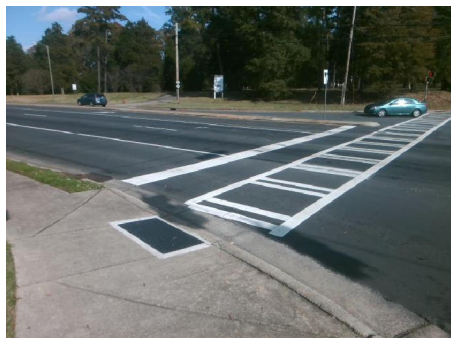
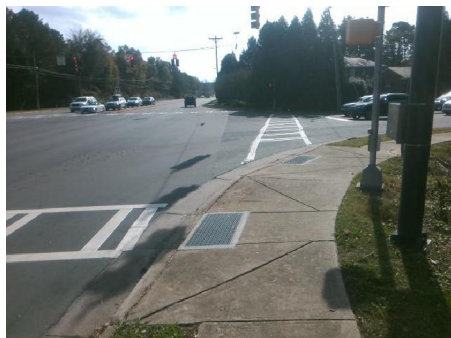
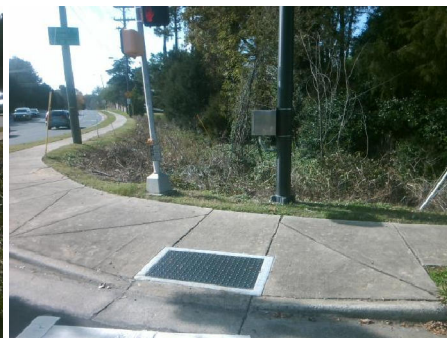
Not Found, R304.5.1, R304.2.2, R304.5.3

Compliance	Description	Data	Compliance	Description	Data
N/A	Ramp Length (in)	78.0	No	Ramp Slope (%)	10.1
No	Ramp Width (in)	44.0	No	Ramp XSlope (%)	3.9
N/A	Flare Type LT	N/A	N/A	Flare Type RT	N/A
N/A	Flare Slope LT (%)	N/A	N/A	Flare Slope RT (%)	N/A
N/A	Flare Traversable LT?	N/A	N/A	Flare Traversable RT?	N/A
N/A	Landing Length (in)	N/A	N/A	DWS Provided?	N/A
N/A	Landing Width (in)	N/A	N/A	DWS Contrast?	N/A
N/A	Landing Slope (%)	N/A	N/A	DWS Length (in)	N/A
N/A	Landing X Slope (%)	N/A	N/A	DWS Full Width?	N/A
N/A	Landing Curb? (Y/N)	N/A	N/A	DWS Offset (in)	N/A
N/A	Shared Landing?	N/A			
N/A	Gutter Ponding?	N/A	N/A	Gutter Slope (%)	N/A
N/A	Gutter Lip Ht (in)	N/A	N/A	Gutter X Slope (%)	N/A
N/A	Painted X Walk1?	Yes	N/A	Painted X Walk2?	N/A
	X Walk 1 Direction	To E		X Walk 2 Direction	N/A
N/A	X Walk 1 Width (in)	65.0	N/A	X Walk 2 Width (in)	N/A
	X Walk 1 Slope (%)	0.7		X Walk 2 Slope (%)	N/A
	X Walk 1 X Slope (%)	1.0		X Walk 2 X Slope (%)	N/A

N/A	Ramp inside XWalk1?	Yes	N/A	Ramp inside XWalk2?	N/A
	Road Slope (%)	N/A	N/A	Clear Space?	N/A
	Road X Slope (%)	N/A	N/A	Clear Space to XWalk (in)	N/A
N/A	Any Obstructions?	N/A	N/A	Storm Grate/Utility Hazard?	N/A
	Obstruction Type			Storm Grate/Utility Type	
		N/A			N/A
		Yes		Surface Condition? (G/P)	Good

Remove & Replace Entire Ramp.
