Access Compliance Report Public Rights-of-Way (Curb Ramps)

Intersection ID: N/A Main Street: SCHOLASTIC DR **Cross Street: KNOWLEDGE CR** Location: Ε **Overall Compliance: No Severity Score:** 12.5 **ADA ID: B87AA134FB82** Ramp Type: Perp Initial Pass/Fail: Fail

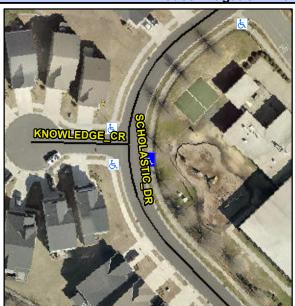
9.2

Ramp Slope (%)

Possible Solutions:	Compli	ance	Description
Remove & Replace Entire Ramp.	N/A	Ramp	Length (in)
·	Yes	Ramp	Width (in)
	N/A	Flare	Type LT
	N/A	Flare	Slope LT (%)
	N/A	Flare	Traversable LT
	N/A	Landi	ng Length (in)
Surveyor Notes:	N/A	Landi	ng Width (in)
N/A	N/A	Landi	ng Slope (%)
	N/A	Landi	ng X Slope (%)
	N/A	Landi	ng Curb? (Y/N
	N/A	Share	ed Landing?
PROW/ADA:	N/A	Gutte	er Ponding?
Not Found, R304.2.2	N/A	Gutte	r Lip Ht (in)
	N/A	Paint	ed X Walk1?
		X Wa	lk 1 Direction
	N/A	X Wa	lk 1 Width (in)
		X Wa	lk 1 Slope (%)
		X Wa	lk 1 X Slope (%
