Access Compliance Report

Public Rights-of-Way

(Curb Ramps)

Intersection ID: 17250	Main Street: CROYDON_RD	Cross Street: QUEENS_RD_WEST	Location: SW
ADA ID: B882053C7C79	Ramp Type: Perp	Initial Pass/Fail: Fail	Overall Compliance: No
		Severity Score: 50

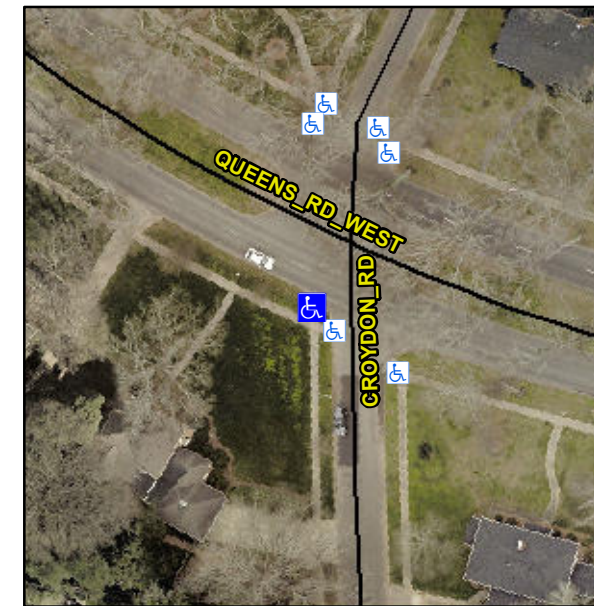
Not Found, R304.2.2, R304.5.3

Compliance	Description	Data	Compliance	Description	Data
N/A	Ramp Length (in)	30.0	No	Ramp Slope (%)	13.3
Yes	Ramp Width (in)	50.0	No	Ramp XSlope (%)	7.1
N/A	Flare Type LT	N/A	N/A	Flare Type RT	N/A
N/A	Flare Slope LT (%)	N/A	N/A	Flare Slope RT (%)	N/A
N/A	Flare Traversable LT?	N/A	N/A	Flare Traversable RT?	N/A
N/A	Landing Length (in)	N/A	N/A	DWS Provided?	N/A
N/A	Landing Width (in)	N/A	N/A	DWS Contrast?	N/A
N/A	Landing Slope (%)	N/A	N/A	DWS Length (in)	N/A
N/A	Landing X Slope (%)	N/A	N/A	DWS Full Width?	N/A
N/A	Landing Curb? (Y/N)	N/A	N/A	DWS Offset (in)	N/A
N/A	Shared Landing?	N/A			
N/A	Gutter Ponding?	N/A	N/A	Gutter Slope (%)	N/A
N/A	Gutter Lip Ht (in)	N/A	N/A	Gutter X Slope (%)	N/A
N/A	Painted X Walk1?	No	N/A	Painted X Walk2?	N/A
	X Walk 1 Direction	To NW		X Walk 2 Direction	N/A
N/A	X Walk 1 Width (in)	N/A	N/A	X Walk 2 Width (in)	N/A
	X Walk 1 Slope (%)	2.3		X Walk 2 Slope (%)	N/A
	X Walk 1 X Slope (%)	1.1		X Walk 2 X Slope (%)	N/A

N/A	Ramp inside XWalk1?	N/A	N/A	Ramp inside XWalk2?	N/A
	Road Slope (%)	N/A	N/A	Clear Space?	N/A
	Road X Slope (%)	N/A	N/A	Clear Space to XWalk (in)	N/A
N/A	Any Obstructions?	N/A	N/A	Storm Grate/Utility Hazard?	N/A
	Obstruction Type			Storm Grate/Utility Type	
		N/A			N/A
			Yes	Surface Condition? (G/P)	Good

Remove & Replace Entire Ramp.
