Access Compliance Report

Public Rights-of-Way

(Curb Ramps)

Intersection ID: 14523	Main Street: LEXINGTON_AV	Cross Street: ROMANY_RD	Location: E
ADA ID: B892F5A4C853	Ramp Type: Perp	Initial Pass/Fail: Fail	Overall Compliance: No
Severity Score: 12.5			
Codes/Mitigation Info/Possible Solution		Field Measurements/Component Compliance

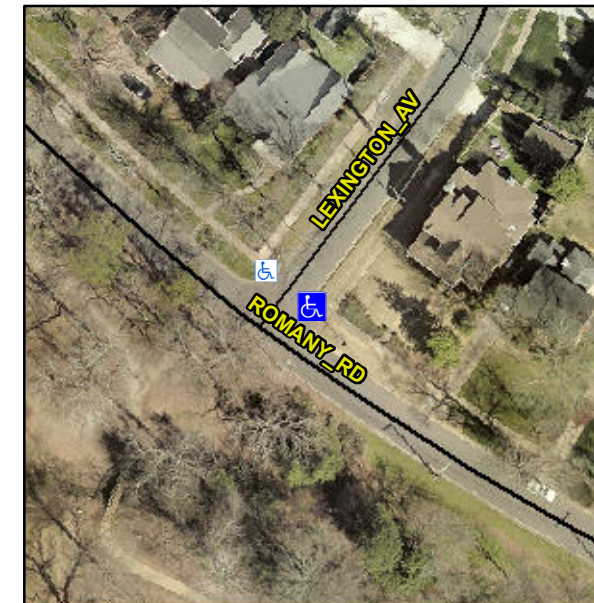
PROW/ADA:

Not Found, R304.5.3

Compliance	Description	Data	Compliance	Description	Data
N/A	Ramp Length (in)	64.0	Yes	Ramp Slope (%)	6.0
Yes	Ramp Width (in)	48.0	No	Ramp XSlope (%)	5.2
N/A	Flare Type LT	N/A	N/A	Flare Type RT	N/A
N/A	Flare Slope LT (%)	N/A	N/A	Flare Slope RT (%)	N/A
N/A	Flare Traversable LT?	N/A	N/A	Flare Traversable RT?	N/A
N/A	Landing Length (in)	N/A	N/A	DWS Provided?	N/A
N/A	Landing Width (in)	N/A	N/A	DWS Contrast?	N/A
N/A	Landing Slope (%)	N/A	N/A	DWS Length (in)	N/A
N/A	Landing X Slope (%)	N/A	N/A	DWS Full Width?	N/A
N/A	Landing Curb? (Y/N)	N/A	N/A	DWS Offset (in)	N/A
N/A	Shared Landing?	N/A			
N/A	Gutter Ponding?	N/A	N/A	Gutter Slope (%)	N/A
N/A	Gutter Lip Ht (in)	N/A	N/A	Gutter X Slope (%)	N/A
N/A	Painted X Walk1?	No	N/A	Painted X Walk2?	N/A
	X Walk 1 Direction	To NW		X Walk 2 Direction	N/A
N/A	X Walk 1 Width (in)	N/A	N/A	X Walk 2 Width (in)	N/A
	X Walk 1 Slope (%)	9.2		X Walk 2 Slope (%)	N/A
	X Walk 1 X Slope (%)	2.1		X Walk 2 X Slope (%)	N/A

Possible Solutions:

Remove & Replace Entire Ramp.

Total Cost: \$ 1850.00
