Access Compliance Report Public Rights-of-Way (Curb Ramps)

Intersection ID: 9070Main Street: CAMPUS_STCross Street: DUNDEEN_STLocation: WADA ID: B89F4624BB1BRamp Type: ParaInitial Pass/Fail: FailOverall Compliance: NoSeverity Score: 12.5

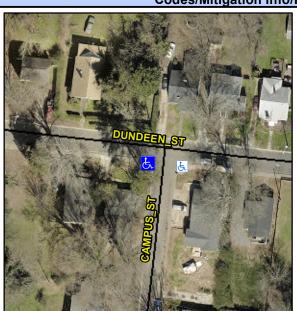
Compliance Description Data Compliance Description Data						
		Data			Data	
N/A	Ramp Length LT (in)	56.0	N/A	Ramp Length RT (in)	53.5	
Yes	Ramp Width LT (in)	60.0	Yes	Ramp Width RT (in)	60.0	
Yes	Ramp Slope LT (%)	5.8	No	Ramp Slope RT (%)	10.0	
Yes	Ramp XSlope LT (%)	1.6	Yes	Ramp XSlope RT (%)	0.5	
N/A	Landing Length (in)	N/A	N/A	DWS Provided?	N/A	
N/A	Landing Width (in)	N/A	N/A	DWS Contrast?	N/A	
N/A	Landing Slope (%)	N/A	N/A	DWS Length (in)	N/A	
N/A	Landing X Slope (%)	N/A	N/A	DWS Full Width?	N/A	
N/A	Landing Curb? (Y/N)	N/A	N/A	DWS Offset (in)	N/A	
N/A	Shared Landing?	N/A				
N/A	Gutter Ponding?	N/A	N/A	Gutter Slope (%)	N/A	
N/A	Gutter Lip Ht (in)	N/A	N/A	Gutter X Slope (%)	N/A	
N/A	Painted X Walk1?	No	N/A	Painted X Walk2?	N/A	
	X Walk 1 Direction	To E		X Walk 2 Direction	N/A	
N/A	X Walk 1 Width (in)	N/A	N/A	X Walk 2 Width (in)	N/A	
	X Walk 1 Slope (%)	0.5		X Walk 2 Slope (%)	N/A	
	X Walk 1 X Slope (%)	7.0		X Walk 2 X Slope (%)	N/A

N/A	Ramp inside XWalk1?	N/A	N/A	Ramp inside XWalk2?	N/A	
	Road Slope (%)	N/A	N/A	Clear Space?	N/A	
	Road X Slope (%)	N/A	N/A	Clear Space to XWalk (in)	N/A	
N/A	Any Obstructions?	N/A	N/A	Storm Grate/Utility Hazard?	N/A	
	Obstruction Type			Storm Grate/Utility Type		
		N/A			N/A	
			Yes	Surface Condition? (G/P)	Good	
			N/A	Curb Slope (%)	10.0	
7	110

Possible Solution	
Possible Solutions:	Co
Remove & Replace Entire Ramp.	N/A
·	Yes
	Yes
	Yes
	N/A
	N/A
Surveyor Notes:	N/A
N/A	N/A
	N/A
	N/A
	N/A
PROW/ADA:	N/A
R304.3.2	N/A
	N/A
	N/A
