Access Compliance Report

Public Rights-of-Way

(Curb Ramps)

Intersection ID: 20039	Main Street: PROVIDENCE_RD	Cross Street: MAMMOTH_OAKS_DR	Location: E
ADA ID: B8A18706A0F8	Ramp Type: PerpDiag	Initial Pass/Fail: Fail	Overall Compliance: No
		Severity Score: 37.5

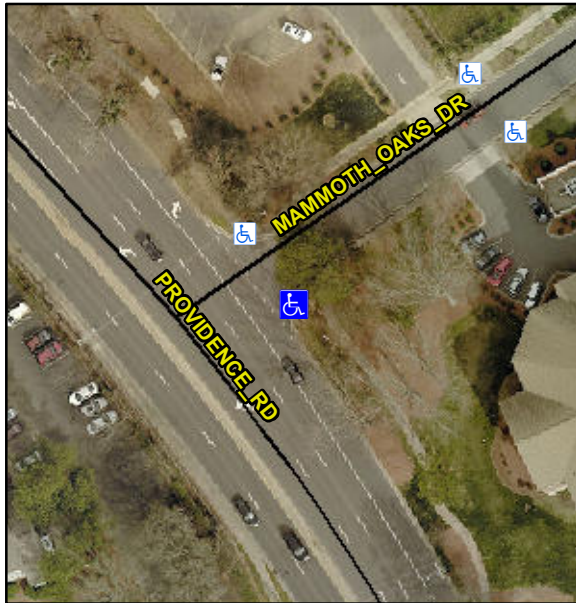
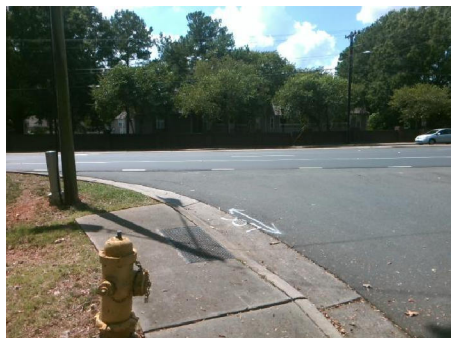
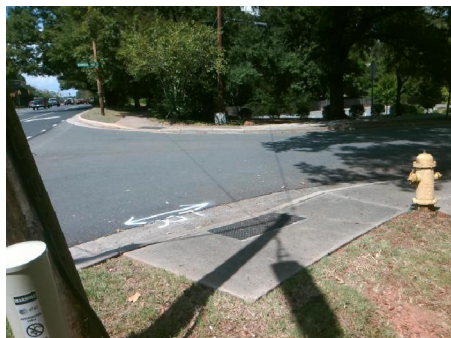
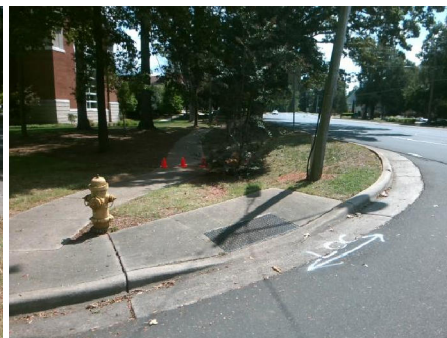
Not Found, R304.2.2, R304.5.3

Compliance	Description	Data	Compliance	Description	Data
N/A	Ramp Length (in)	60.0	No	Ramp Slope (%)	9.3
Yes	Ramp Width (in)	48.0	No	Ramp XSlope (%)	8.6
N/A	Flare Type LT	N/A	N/A	Flare Type RT	N/A
N/A	Flare Slope LT (%)	N/A	N/A	Flare Slope RT (%)	N/A
N/A	Flare Traversable LT?	N/A	N/A	Flare Traversable RT?	N/A
N/A	Landing Length (in)	N/A	N/A	DWS Provided?	N/A
N/A	Landing Width (in)	N/A	N/A	DWS Contrast?	N/A
N/A	Landing Slope (%)	N/A	N/A	DWS Length (in)	N/A
N/A	Landing X Slope (%)	N/A	N/A	DWS Full Width?	N/A
N/A	Landing Curb? (Y/N)	N/A	N/A	DWS Offset (in)	N/A
N/A	Shared Landing?	N/A			
N/A	Gutter Ponding?	N/A	N/A	Gutter Slope (%)	N/A
N/A	Gutter Lip Ht (in)	N/A	N/A	Gutter X Slope (%)	N/A
N/A	Painted X Walk1?	No	N/A	Painted X Walk2?	No
	X Walk 1 Direction	To NW		X Walk 2 Direction	To SW
N/A	X Walk 1 Width (in)	N/A	N/A	X Walk 2 Width (in)	N/A
	X Walk 1 Slope (%)	8.5		X Walk 2 Slope (%)	11.2
	X Walk 1 X Slope (%)	10.4		X Walk 2 X Slope (%)	4.8

N/A	Ramp inside XWalk1?	N/A	N/A	Ramp inside XWalk2?	N/A
	Road Slope (%)	10.5	N/A	Clear Space?	N/A
	Road X Slope (%)	10.8	N/A	Clear Space to XWalk (in)	N/A
N/A	Any Obstructions?	N/A	N/A	Storm Grate/Utility Hazard?	N/A
	Obstruction Type			Storm Grate/Utility Type	
		N/A			N/A
			Yes	Surface Condition? (G/P)	Good

Remove & Replace Curb Ramp With Two New Directional Ramps or Equivalent.

Total Cost: \$ 3200.00
