## Access Compliance Report Public Rights-of-Way (Curb Ramps)

Intersection ID: 11098Main Street: GESCO\_STCross Street: TUCKASEEGEE\_RDLocation:WADA ID: B8AC6BCD2CBDRamp Type: PerpInitial Pass/Fail: FailOverall Compliance: NoSeverity Score: 50

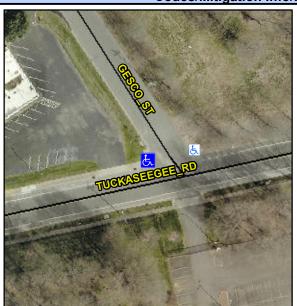
Comp	liance Description	Data	Compl	liance	Description	Data
N/A	Ramp Length (in)	64.5	No	Ramp	Slope (%)	13.1
Yes	Ramp Width (in)	62.0	No	Ramp	XSlope (%)	7.3
N/A	Flare Type LT	N/A	N/A	Flare	Type RT	N/A
N/A	Flare Slope LT (%)	N/A	N/A	Flare	Slope RT (%)	N/A
N/A	Flare Traversable LT?	N/A	N/A	Flare	Traversable RT?	N/A
N/A	Landing Length (in)	N/A	N/A	DWS	Provided?	N/A
N/A	Landing Width (in)	N/A	N/A	DWS	Contrast?	N/A
N/A	Landing Slope (%)	N/A	N/A	DWS	Length (in)	N/A
N/A	Landing X Slope (%)	N/A	N/A	DWS	Full Width?	N/A
N/A	Landing Curb? (Y/N)	N/A	N/A	DWS	Offset (in)	N/A
N/A	Shared Landing?	N/A				
N/A	Gutter Ponding?	N/A	N/A	Gutte	r Slope (%)	N/A
N/A	Gutter Lip Ht (in)	N/A	N/A	Gutte	r X Slope (%)	N/A
N/A	Painted X Walk1?	No	N/A	Painte	ed X Walk2?	N/A
	X Walk 1 Direction	То Е		X Wa	lk 2 Direction	N/A
N/A	X Walk 1 Width (in)	N/A	N/A	X Wa	lk 2 Width (in)	N/A
	X Walk 1 Slope (%)	0.3		X Wa	lk 2 Slope (%)	N/A
	X Walk 1 X Slope (%)	5.4		X Wa	lk 2 X Slope (%)	N/A

POSSIDIE SOIULIOII	
Possible Solutions:	<u>c</u>
Remove & Replace Entire Ramp.	N
·	Ye
	N/
	N
	N
	N
Surveyor Notes:	N
N/A	N
	N
	N
	N
PROW/ADA:	N
Not Found, R304.2.2, R304.5.3	N/
	N
	N
