# Access Compliance Report

## Public Rights-of-Way

| Intersection ID: 19146 | Main Street: TYVOLA_RD | Cross Street: WEDGEWOOD_DR | Location: SE |
| ADA ID: B8B6C7DA2371 | Ramp Type: PerpDiag | Initial Pass/Fail: Pass | Overall Compliance: No |

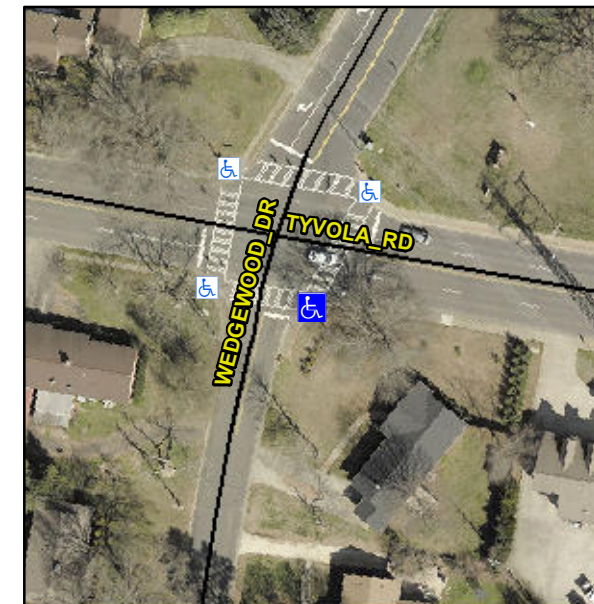
| | | | Severity Score: 10.25 |

**Not Found, R304.5.3, R304.2.1, R304.2.2-Perp, R304.3.2-Para, R305, R302.7**

| Compliance | Description | Data | Compliance | Description | Data |
|---|---|---|---|---|---|
| N/A | Ramp Length (in) | 24.0 | Yes | Ramp Slope (%) | 6.4 |
| Yes | Ramp Width (in) | 125.0 | No | Ramp XSlope (%) | 2.2 |
| No | Landing Length (in) | 32.0 | No | DWS Provided? | No |
| No | Landing Slope (%) | 2.4 | N/A | DWS Length (in) | N/A |
| No | Landing X Slope (%) | 2.2 | N/A | DWS Full Width? | No |
| No | Gutter Ponding? | Yes | Yes | Gutter Slope (%) | 3.8 |

**Remove & Replace Curb Ramp With Two New Directional Ramps or Equivalent.**

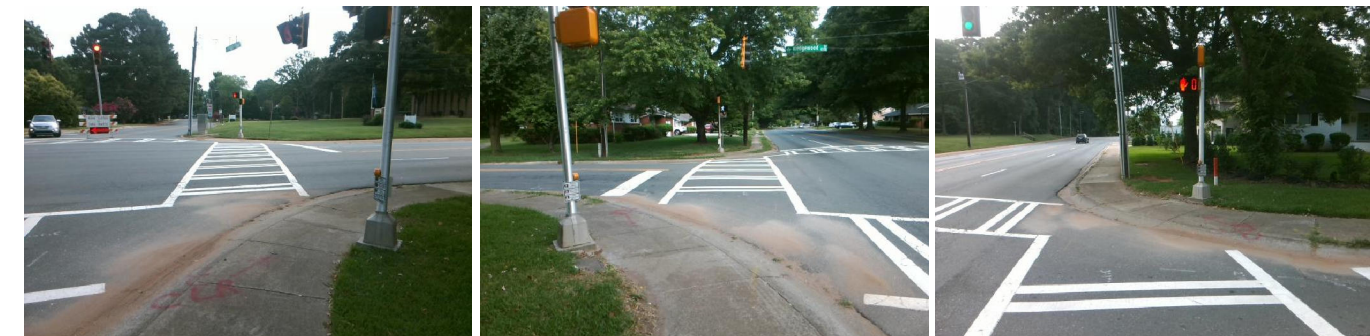
Street 1 Name TYVOLA RD  
 Stop Condition-Street 2 Signal  
 Street 2 Name WEDGEWOOD DR  
 Stop Condition-Street 1 Signal
