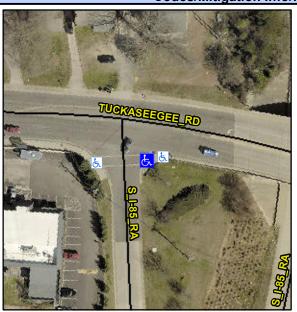
Intersection ID: 10021Main Street: S_I-85_RACross Street: TUCKASEEGEE_RDLocation:EADA ID: B8B705249D3ERamp Type: PerpInitial Pass/Fail: FailOverall Compliance: NoSeverity Score:35

Comp		Data		liance Description	Data
N/A	Ramp Length (in)	68.0	No	Ramp Slope (%)	12.6
No	Ramp Width (in)	45.0	No	Ramp XSlope (%)	2.8
N/A	Flare Type LT	N/A	N/A	Flare Type RT	N/A
N/A	Flare Slope LT (%)	N/A	N/A	Flare Slope RT (%)	N/A
N/A	Flare Traversable LT?	N/A	N/A	Flare Traversable RT?	N/A
N/A	Landing Length (in)	N/A	N/A	DWS Provided?	N/A
N/A	Landing Width (in)	N/A	N/A	DWS Contrast?	N/A
N/A	Landing Slope (%)	N/A	N/A	DWS Length (in)	N/A
N/A	Landing X Slope (%)	N/A	N/A	DWS Full Width?	N/A
N/A	Landing Curb? (Y/N)	N/A	N/A	DWS Offset (in)	N/A
N/A	Shared Landing?	N/A			
N/A	Gutter Ponding?	N/A	N/A	Gutter Slope (%)	N/A
N/A	Gutter Lip Ht (in)	N/A	N/A	Gutter X Slope (%)	N/A
N/A	Painted X Walk1?	Yes	N/A	Painted X Walk2?	N/A
	X Walk 1 Direction	To W		X Walk 2 Direction	N/A
N/A	X Walk 1 Width (in)	112.0	N/A	X Walk 2 Width (in)	N/A
	X Walk 1 Slope (%)	2.9		X Walk 2 Slope (%)	N/A
	X Walk 1 X Slope (%)	1.2		X Walk 2 X Slope (%)	N/A

N/A	Ramp inside XWalk1?	Yes	N/A	Ramp inside XWalk2?	N/A
	Road Slope (%)	N/A	N/A	Clear Space?	N/A
	Road X Slope (%)	N/A	N/A	Clear Space to XWalk (in)	N/A
N/A	Any Obstructions?	N/A	N/A	Storm Grate/Utility Hazard?	N/A
	Obstruction Type			Storm Grate/Utility Type	
		N/A			N/A
			Yes	Surface Condition? (G/P)	Good
