Access Compliance Report

Public Rights-of-Way

(Curb Ramps)

Intersection ID: 29510	Main Street: LYNMONT_DR	Cross Street: CRESCENT_DAY_CT	Location: SW
ADA ID: B8C66237F401	Ramp Type: PerpDiag	Initial Pass/Fail: Fail	Overall Compliance: No
		Severity Score: 10

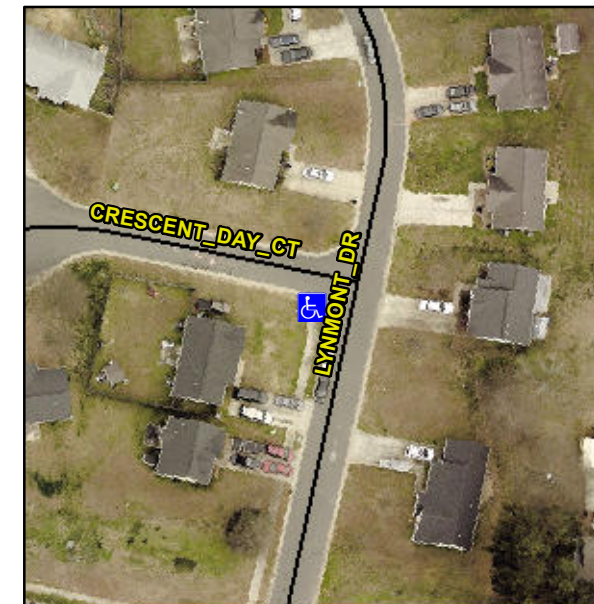
Not Found, R304.5.1, R304.5.3

Compliance	Description	Data	Compliance	Description	Data
N/A	Ramp Length (in)	51.0	Yes	Ramp Slope (%)	8.2
No	Ramp Width (in)	41.0	No	Ramp XSlope (%)	3.5
N/A	Flare Type LT	N/A	N/A	Flare Type RT	N/A
N/A	Flare Slope LT (%)	N/A	N/A	Flare Slope RT (%)	N/A
N/A	Flare Traversable LT?	N/A	N/A	Flare Traversable RT?	N/A
N/A	Landing Length (in)	N/A	N/A	DWS Provided?	N/A
N/A	Landing Width (in)	N/A	N/A	DWS Contrast?	N/A
N/A	Landing Slope (%)	N/A	N/A	DWS Length (in)	N/A
N/A	Landing X Slope (%)	N/A	N/A	DWS Full Width?	N/A
N/A	Landing Curb? (Y/N)	N/A	N/A	DWS Offset (in)	N/A
N/A	Shared Landing?	N/A			
N/A	Gutter Ponding?	N/A	N/A	Gutter Slope (%)	N/A
N/A	Gutter Lip Ht (in)	N/A	N/A	Gutter X Slope (%)	N/A
N/A	Painted X Walk1?	No	N/A	Painted X Walk2?	No
	X Walk 1 Direction	To E		X Walk 2 Direction	To N
N/A	X Walk 1 Width (in)	N/A	N/A	X Walk 2 Width (in)	N/A
	X Walk 1 Slope (%)	4.1		X Walk 2 Slope (%)	0.7
	X Walk 1 X Slope (%)	2.1		X Walk 2 X Slope (%)	3.0

N/A	Ramp inside XWalk1?	N/A	N/A	Ramp inside XWalk2?	N/A
	Road Slope (%)	3.0	N/A	Clear Space?	N/A
	Road X Slope (%)	3.2	N/A	Clear Space to XWalk (in)	N/A
N/A	Any Obstructions?	N/A	N/A	Storm Grate/Utility Hazard?	N/A
	Obstruction Type			Storm Grate/Utility Type	
		N/A			N/A
		Yes		Surface Condition? (G/P)	Good

Remove & Replace Curb Ramp With Two New Directional Ramps or Equivalent.
